**BC Timber Sales - Kamloops Business Area  
Albreda-Dominion 2020  
Visual Assessment and Recommendations  
RDI Resource Design Inc  
February 6, 2020**

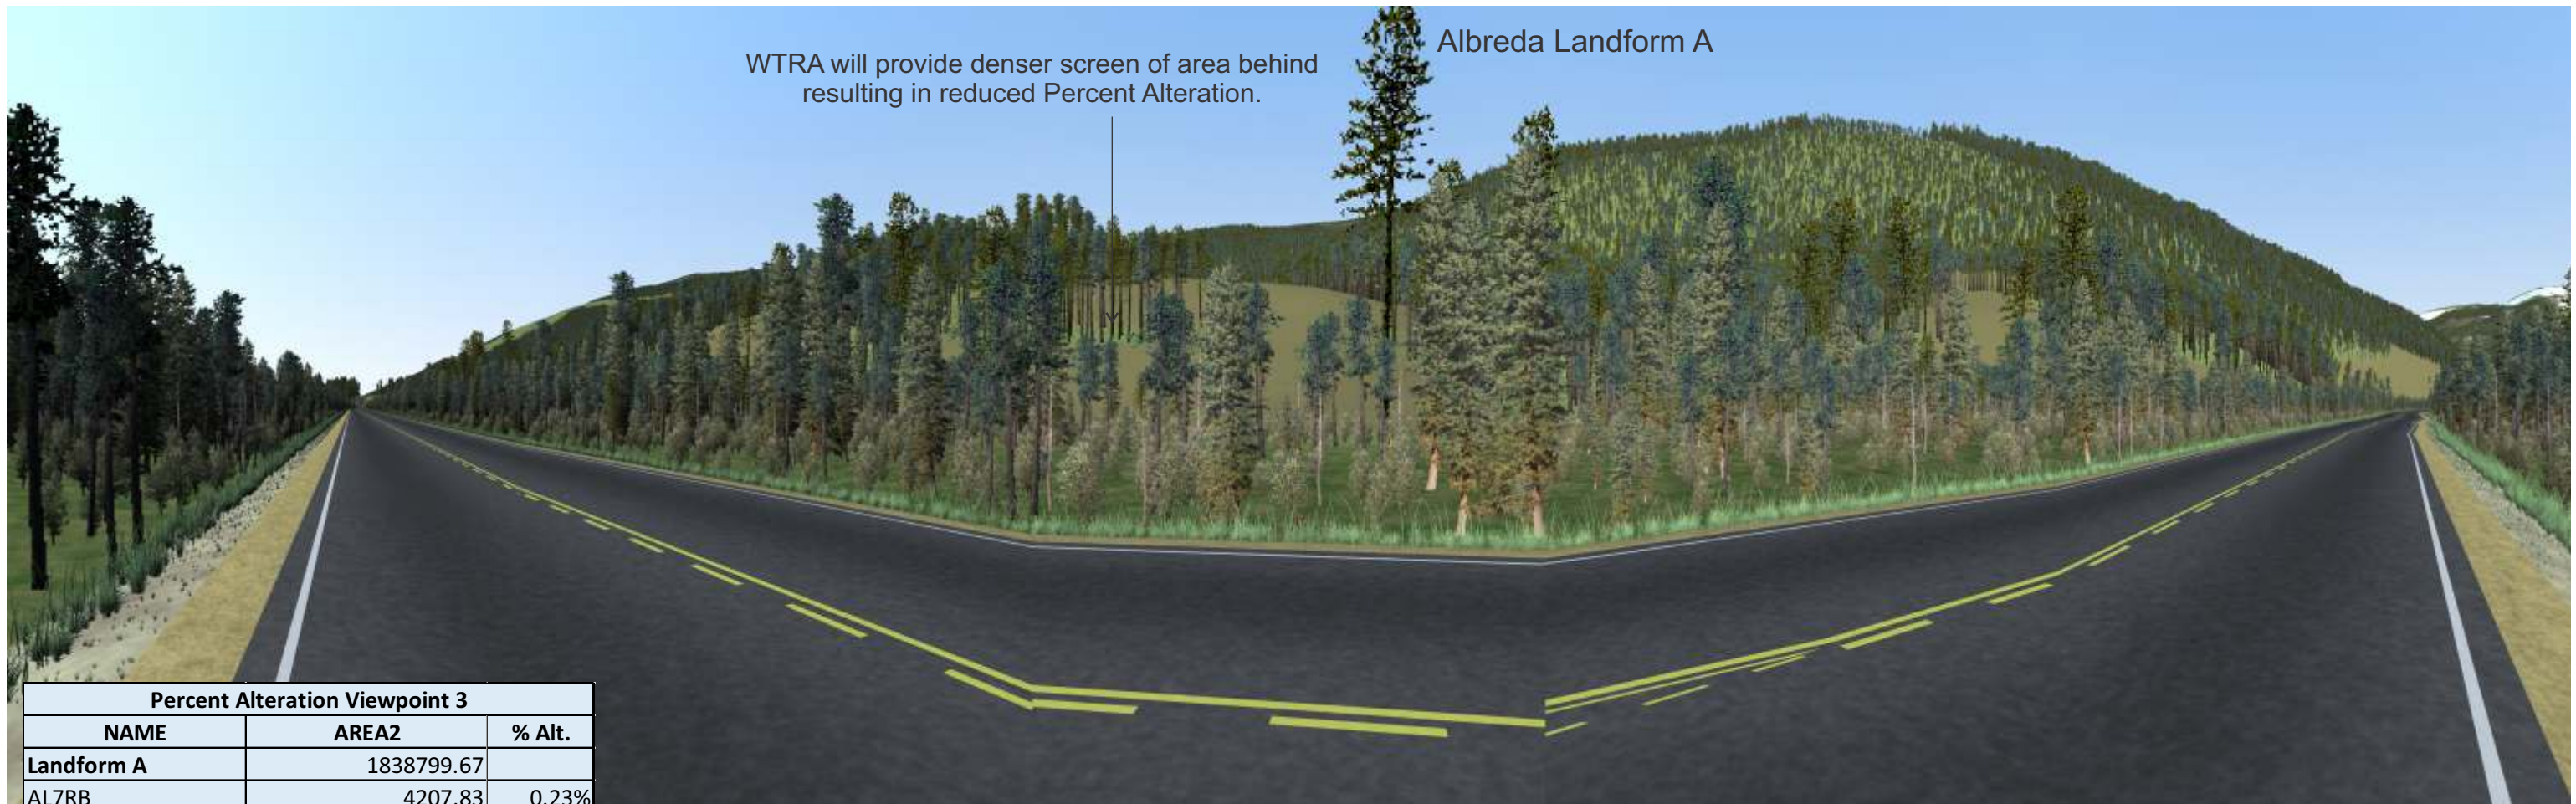
VP 3

- Yes I do think that the roadside screening will be greater than the model displays. We had a similar block further south on the hwy with only a 5 meter buffer placed along the hwy edge and the results were positive post harvest.
- This is a drive by viewing and at 100km/hr you will not see the entire landform A like is displayed on pg 17.
- The WTRA displayed on page 17 beside the 3<sup>rd</sup> AL7RB label from the left shows that the WTRA is see through. This block is comprised primarily of Hemlock & Cedar with the Hemlock's crown generally coming down quite low. Not sure if the area you can see behind the WTRA in the model contributes to the % alteration or not? But we do not think any area beyond the WTRA will be visible.

WTRA will provide denser screen of area behind resulting in reduced Percent Alteration.

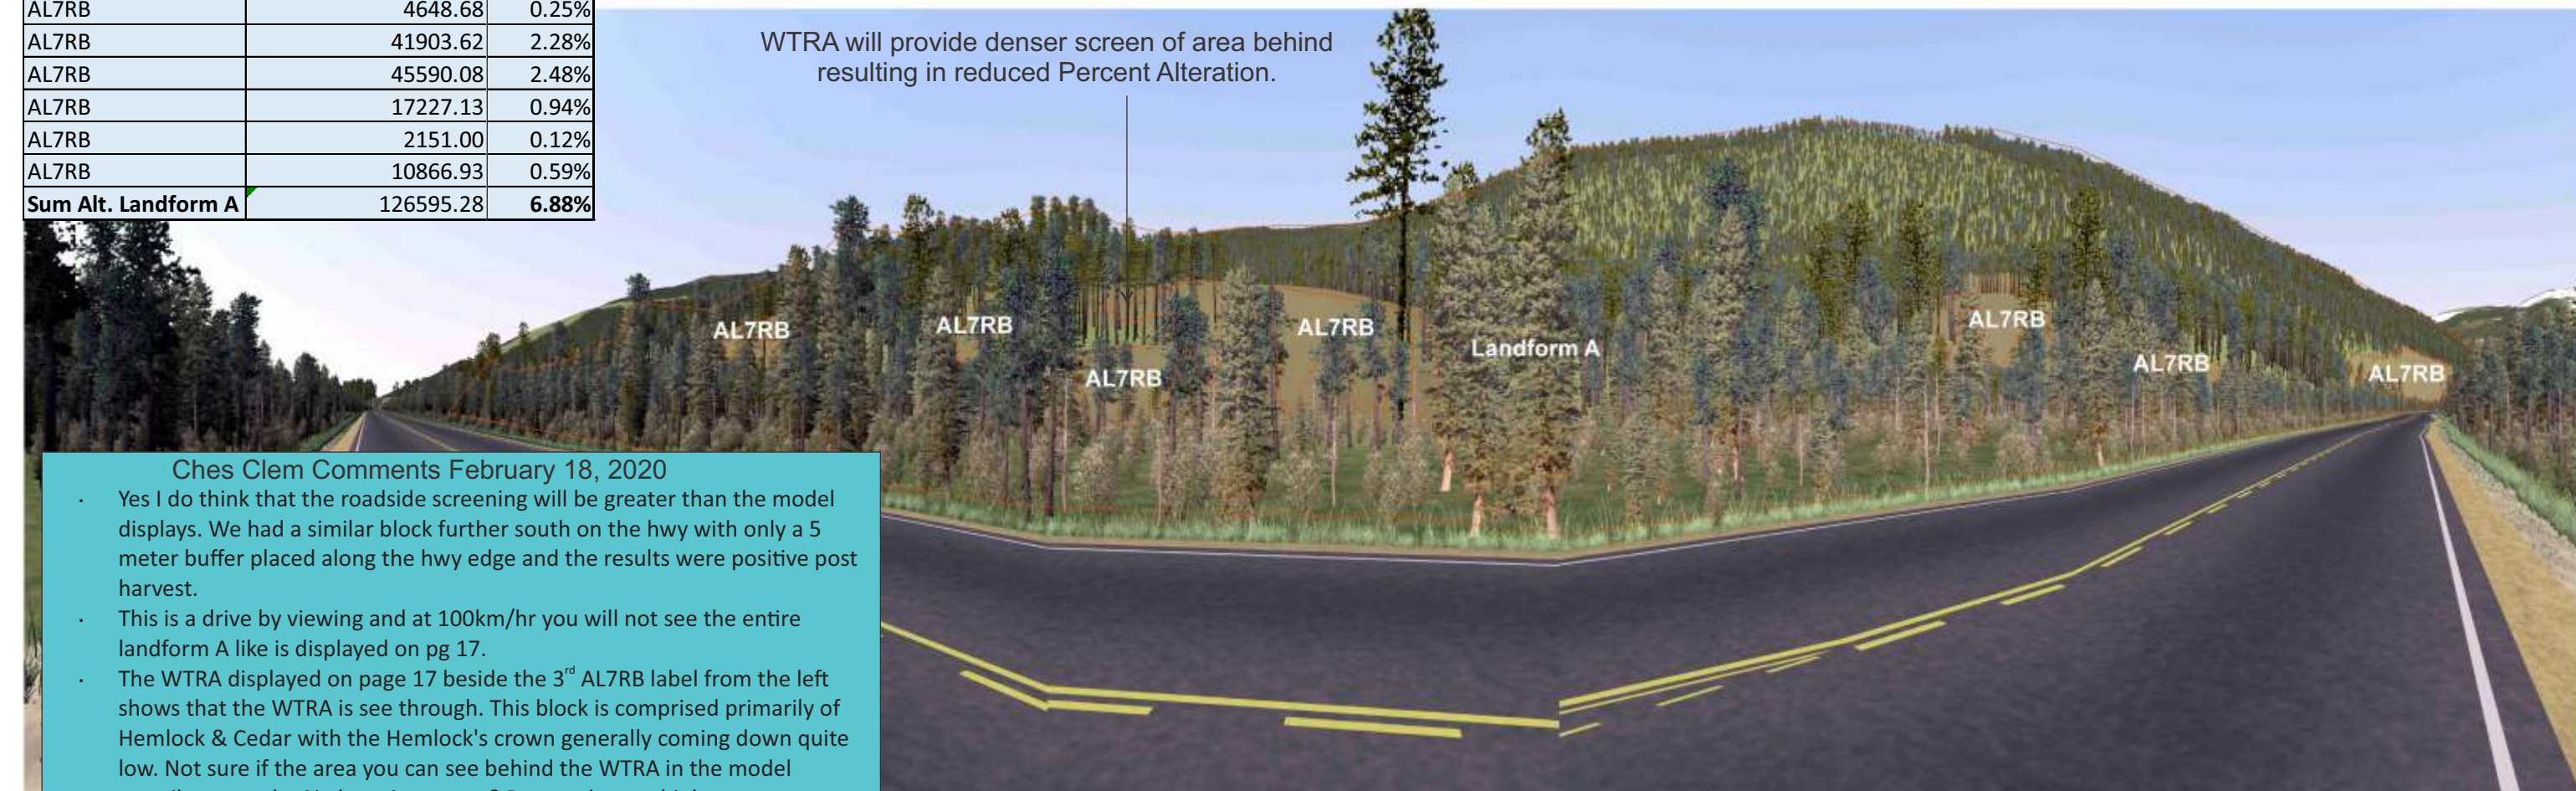
VP 3 Percent Alteration

Percent Alteration Viewpoint 3		
NAME	AREA2	% Alt.
Landform A	1838799.67	
AL7RB	4207.83	0.23%
AL7RB	4648.68	0.25%
AL7RB	41903.62	2.28%
AL7RB	45590.08	2.48%
AL7RB	17227.13	0.94%
AL7RB	2151.00	0.12%
AL7RB	10866.93	0.59%
<b>Sum Alt. Landform A</b>	<b>126595.28</b>	<b>6.88%</b>

WTRA will provide denser screen of area behind resulting in reduced Percent Alteration.

- Yes I do think that the roadside screening will be greater than the model displays. We had a similar block further south on the hwy with only a 5 meter buffer placed along the hwy edge and the results were positive post harvest.
- This is a drive by viewing and at 100km/hr you will not see the entire landform A like is displayed on pg 17.
- The WTRA displayed on page 17 beside the 3<sup>rd</sup> AL7RB label from the left shows that the WTRA is see through. This block is comprised primarily of Hemlock & Cedar with the Hemlock's crown generally coming down quite low. Not sure if the area you can see behind the WTRA in the model contributes to the % alteration or not? But we do not think any area beyond the WTRA will be visible.

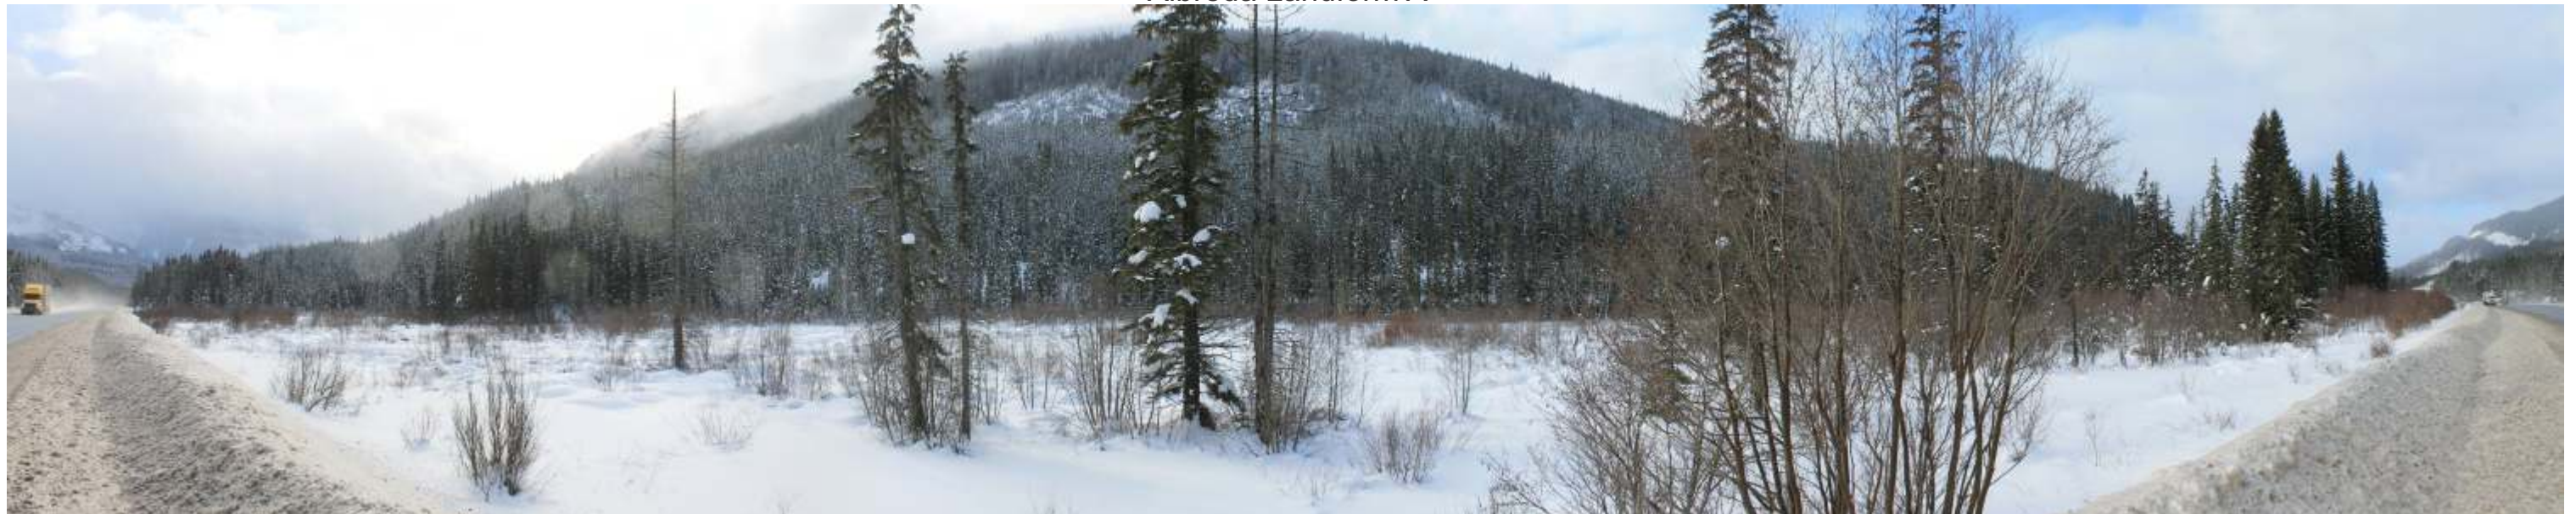
Ches Clem comment February 18, 2020:  
 For viewpoint 7 I agree that your model accurately depicts  
 the road side screening.

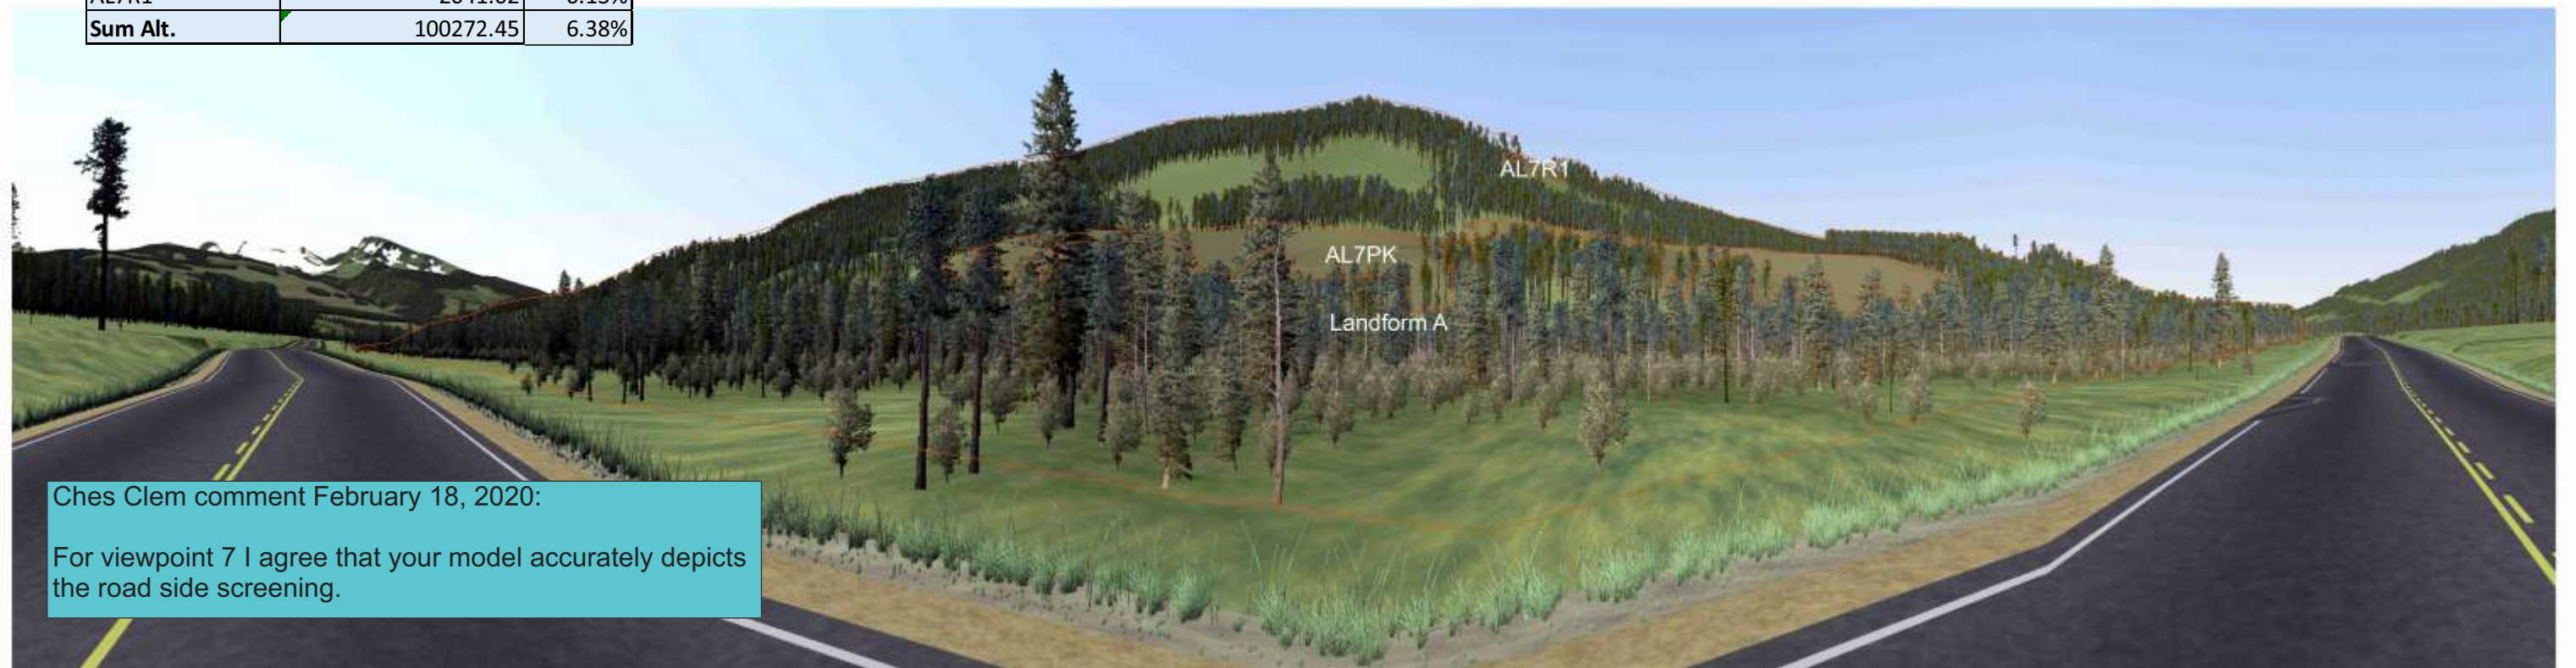
Ches Clem comment February 18, 2020:  
 For viewpoint 7 I agree that your model accurately depicts the road side screening.

AL7R1 (glimpse)

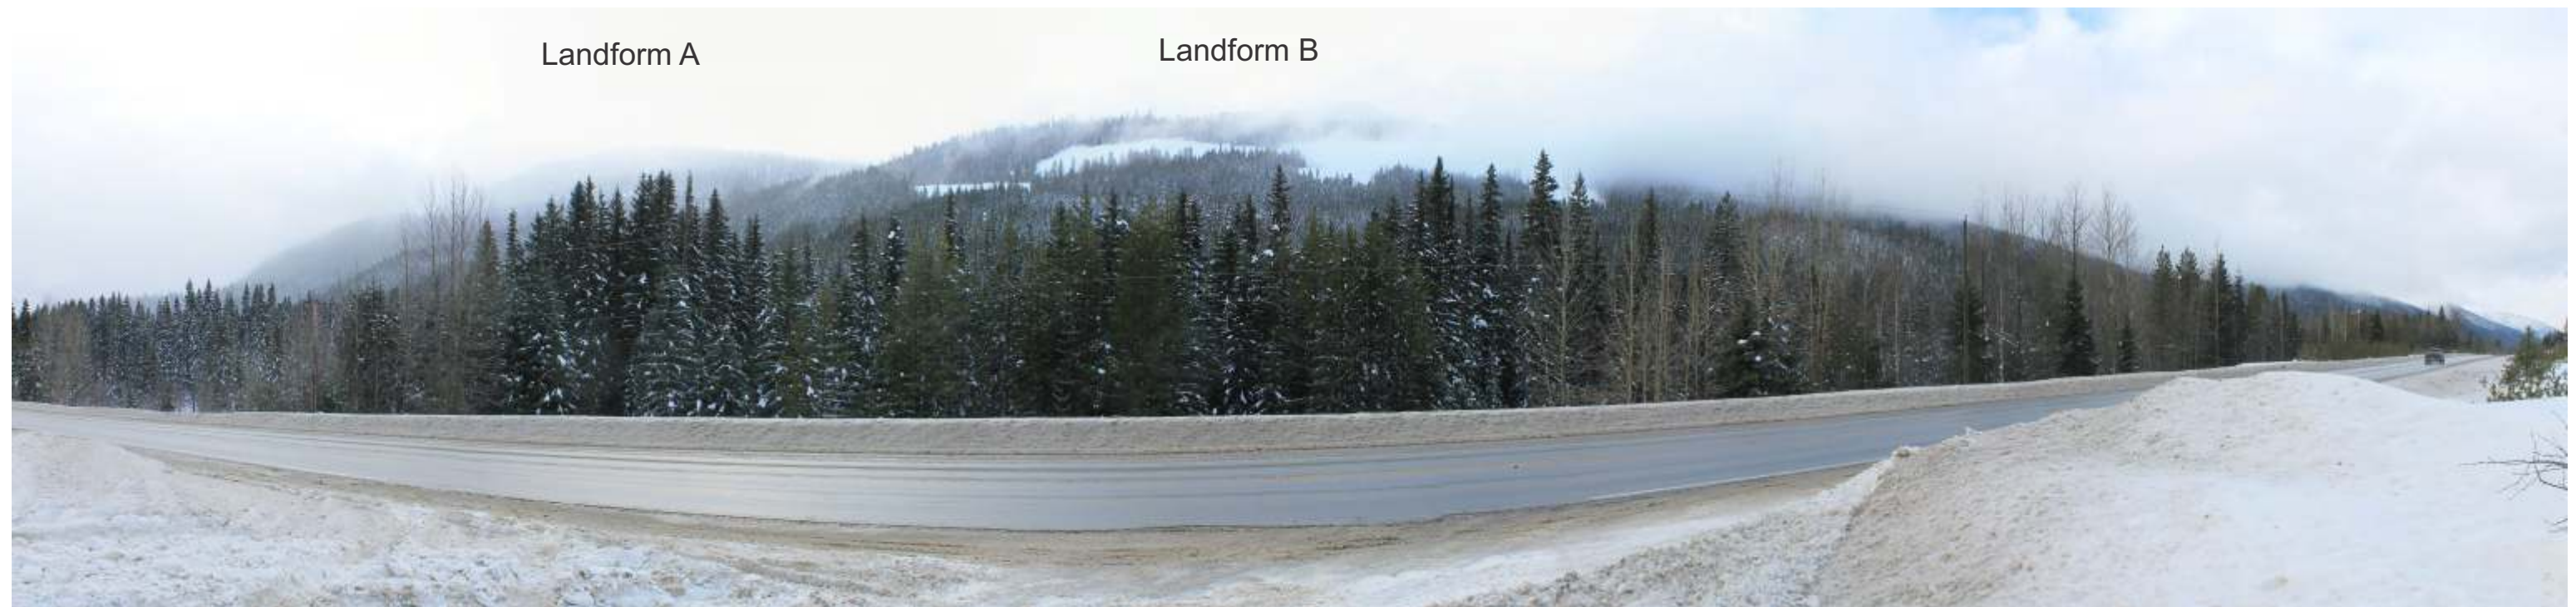
Note: Snowmobile Lot is 7m above highway. AL7PK and AL8PT are mainly screened in views at highway level.

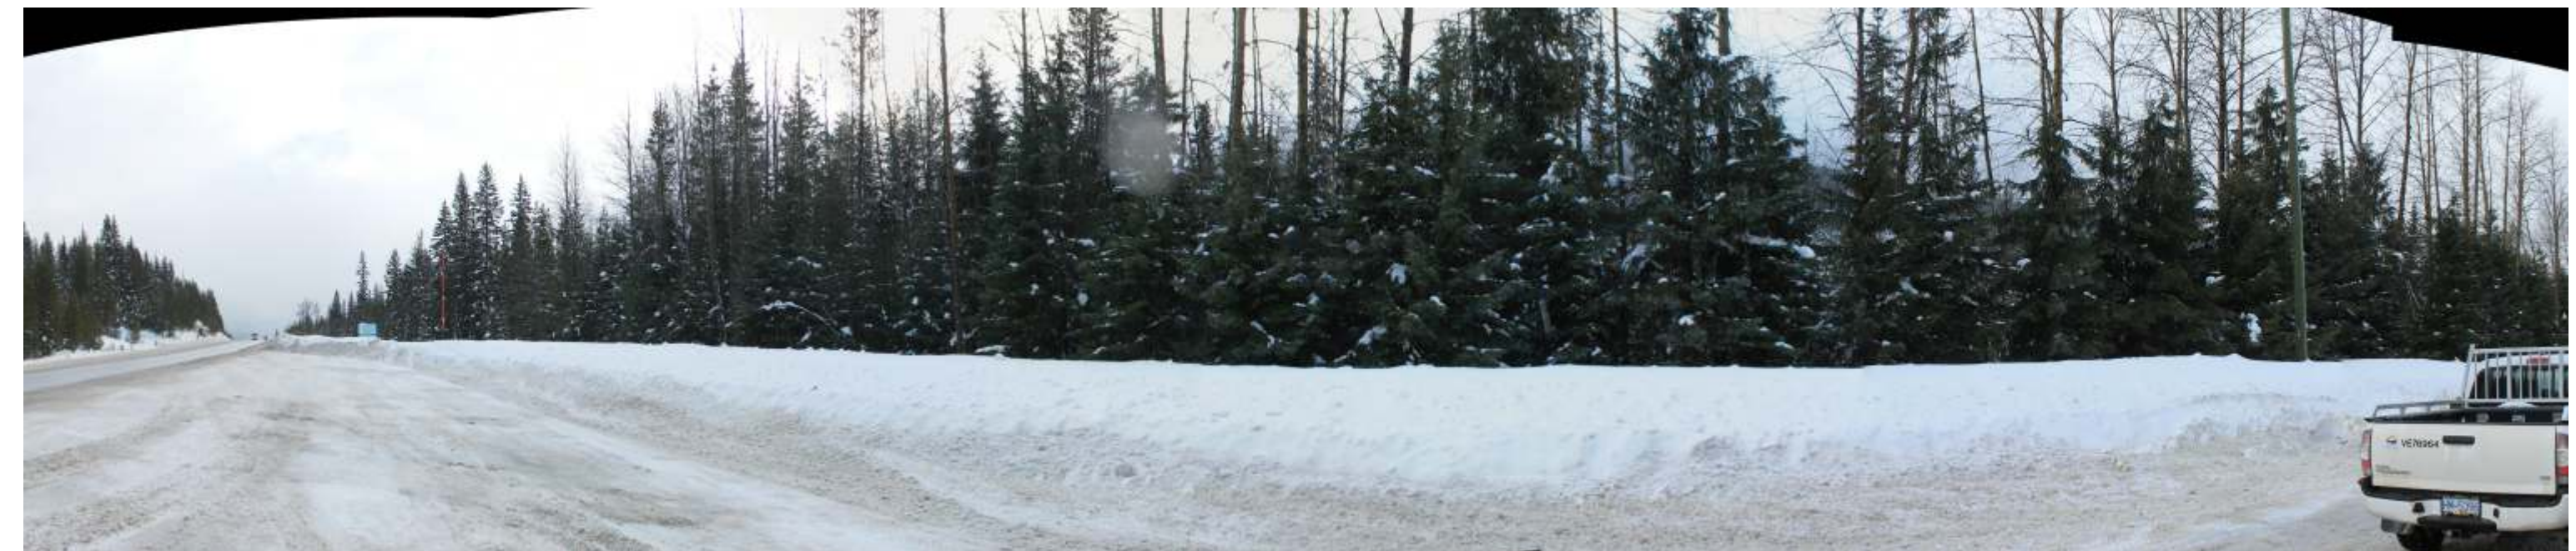
VP 11

All openings likely fully screened - see open view from VP 12
