**North-East Harbour
Final Visual Assessment
October 21, 2017
RDI Resource Design Inc**

Discussion and Conclusions

A visual impact assessment was conducted by RDI for the proposed cutblocks SB95D and SB84X plus a complexity of related existing cutblocks. The analysis cutblocks lay within VSU996 which has an established VQO of Partial Retention, and are located in mapsheet 082m065. Having no opportunity for on-site orientation, RDI sought and tested best viewing opportunities along the roads and on Dudgeon Lake using Visual Nature Studio. The trial approaches consumed considerable rendering effort. In all, 8 viewpoints were selected for analysis. The major portion of SB95D is outside of the VSU on the north-west facing part of the landform. The viewpoints on the west side of Adams River up to and including the bridge crossing (Viewpoint 3.3) see only this unclassified landform. The nearest VSU to the south seen from the west side of the river is VSU 1013 which has an established VQO of Modification. That VSU contains proposed cutblocks SB95C and SB95E which are assessed in a separate report by RDI.

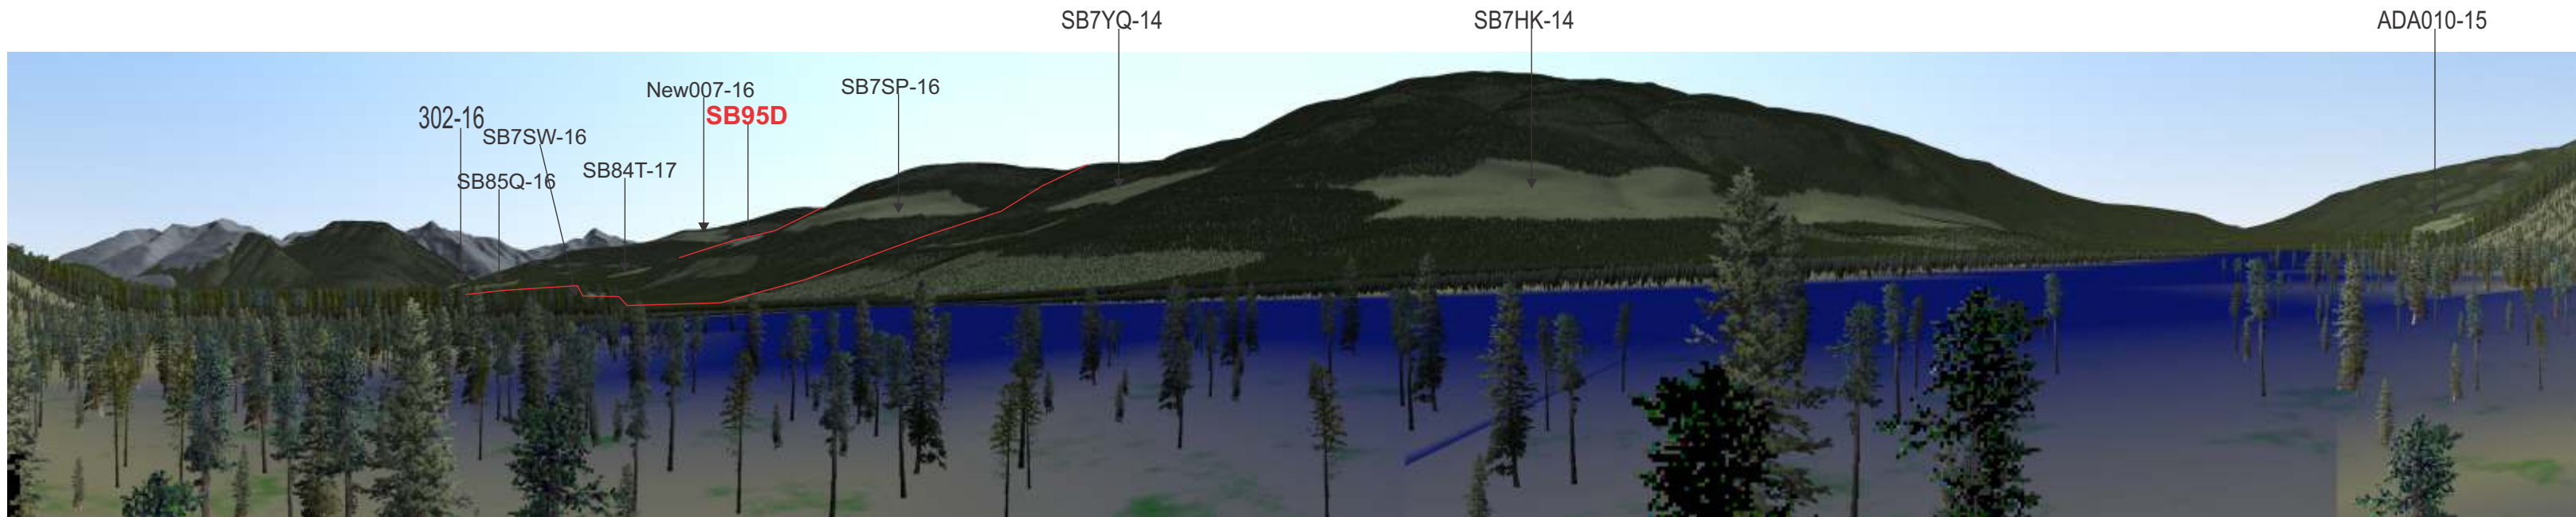
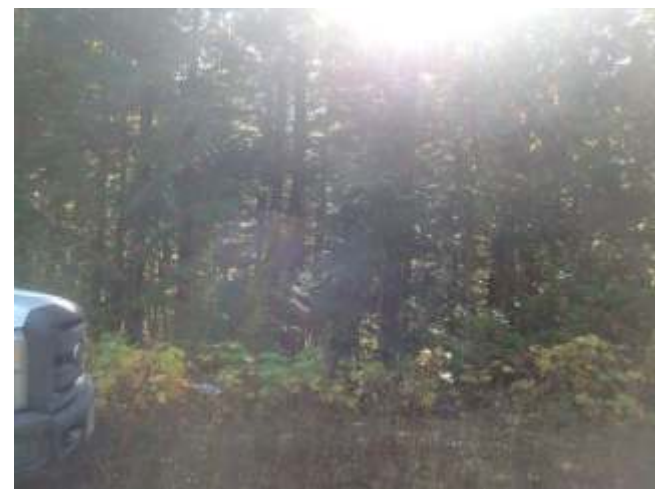
Viewpoint 3.1-River- with clearing- no on-site viewpoint determination

SB95D is a minor element in the landform as identified in red by RDI. The visible portion of the cutblock and entire landscape are outside of current Visual Landscape Inventory. Nearest VSU to south (4k) is Modification. Photo evidence from Tyson Leudtke indicates full screening. No further analysis deemed necessary by RDI.

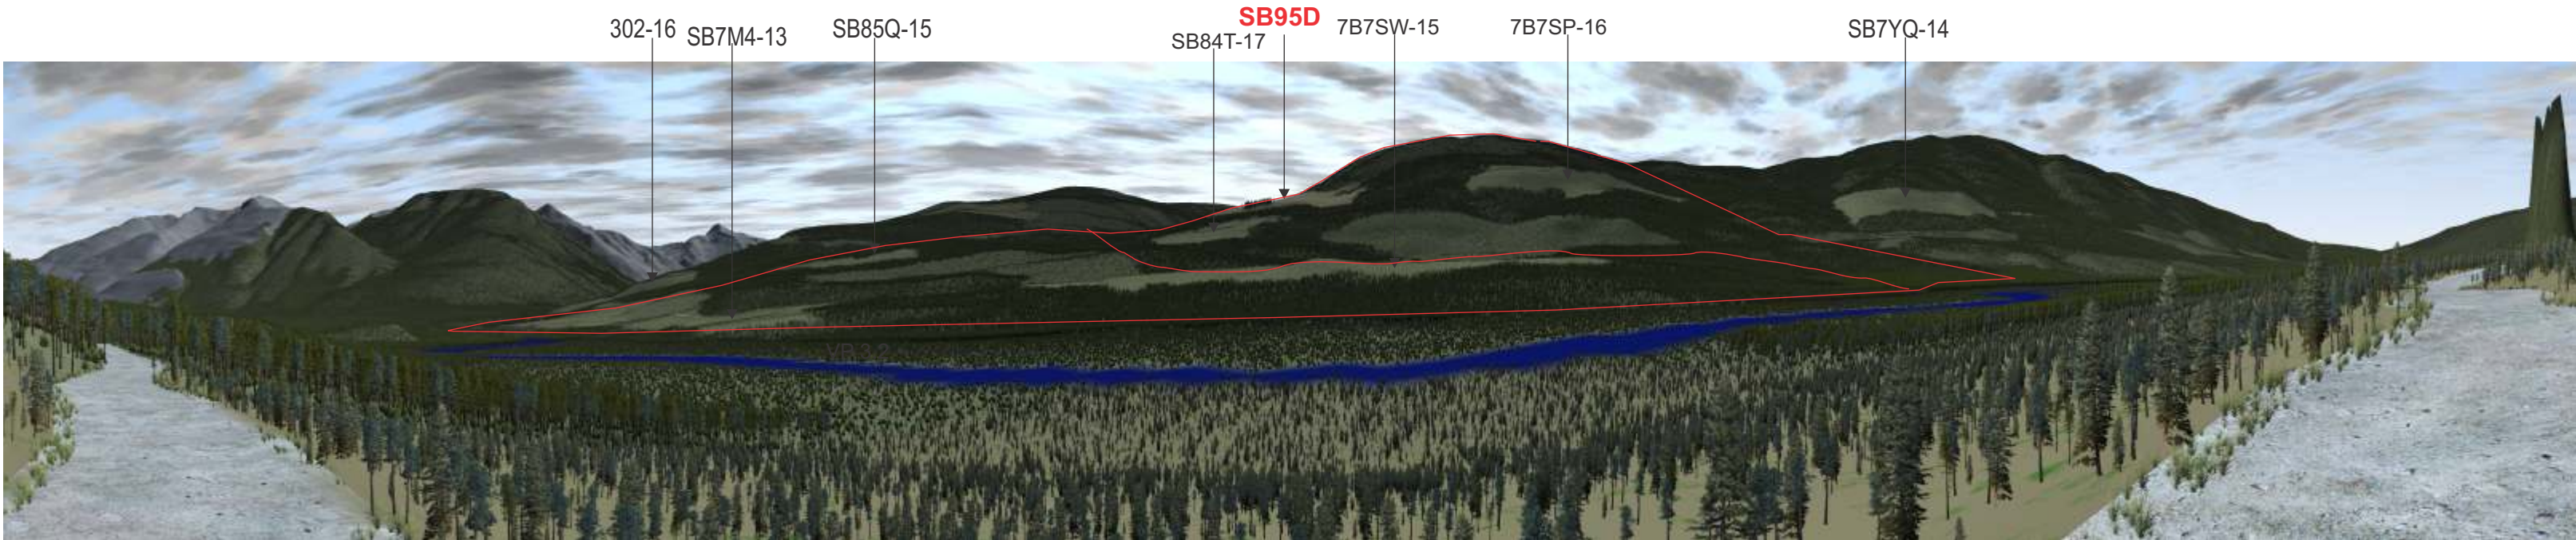
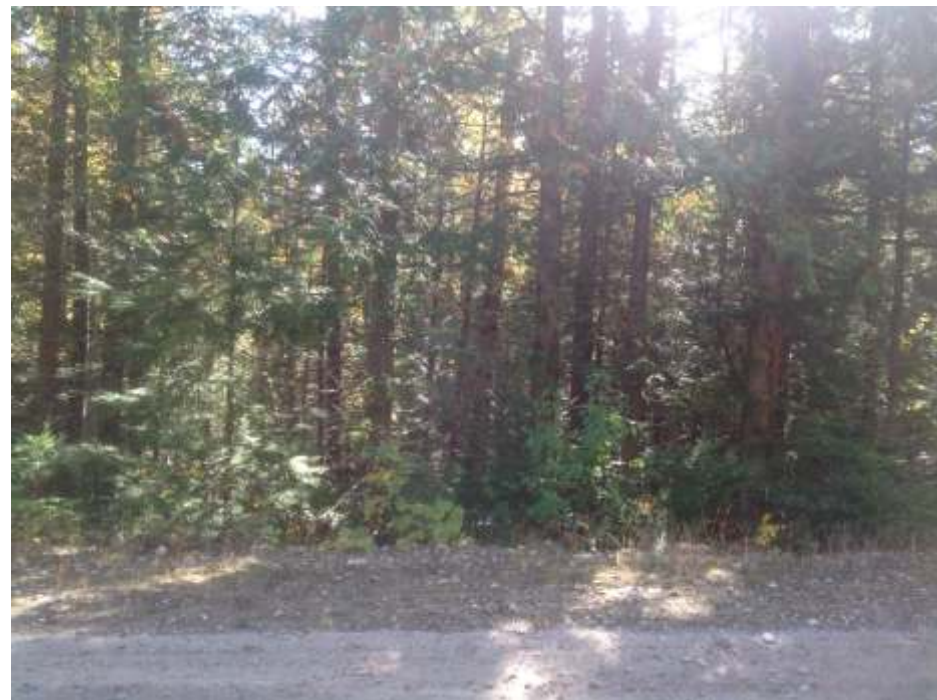
Viewpoint 3.2 - with VP clearing - visibility subject to on-site inspection- no on-site viewpoint determination

SB95D is a well-shaped compatible element in the landform as identified in red by RDI. New and existing cutblocks follow visual force lines. Presence of recent alteration in the same landform (SB84T-17; SB7SP-16) The visible portion of the cutblock and entire landscape are outside of current Visual Landscape Inventory. Nearest VSU to south (4k) is Modification. Photo evidence from Tyson Leudtke indicates full screening. No further analysis deemed necessary by RDI.

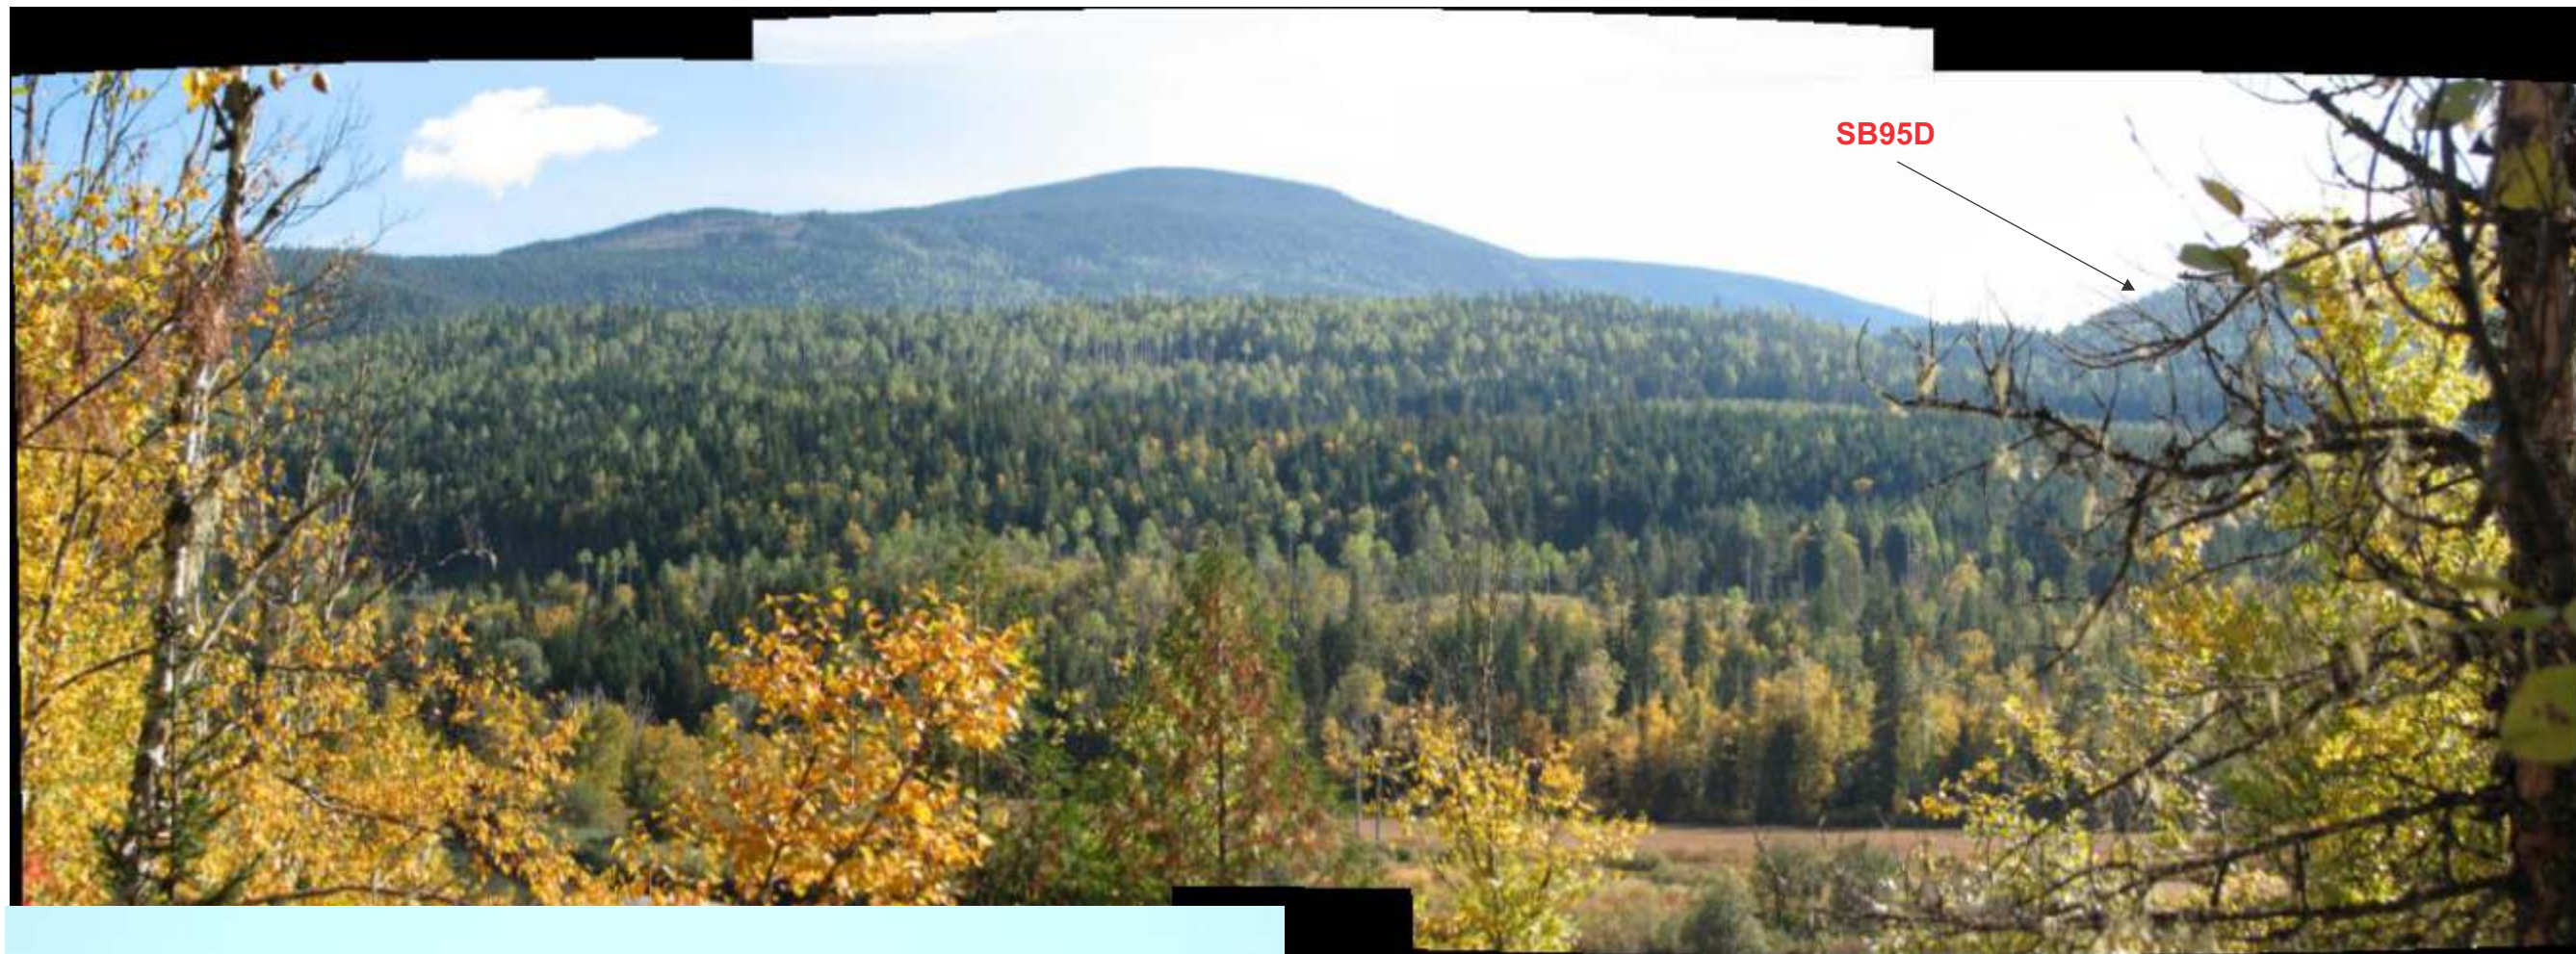
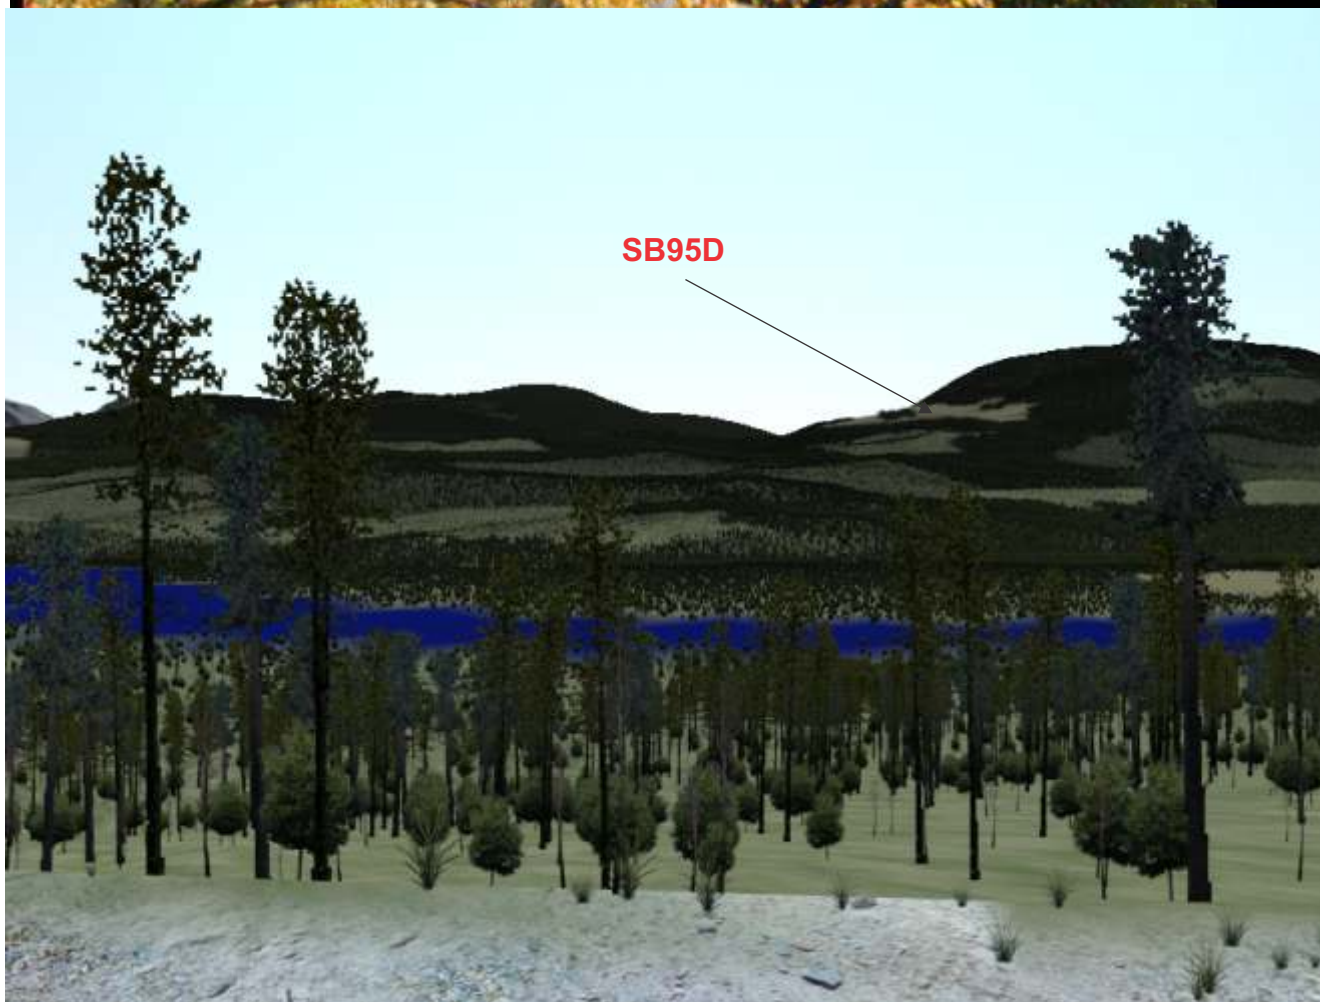
Viewpoint Old Rec. Site

SB95D is a well-shaped compatible element in the landform as identified in red by RDI. New and existing cutblocks follow visual force lines. Presence of recent alteration in the same landform (SB84T-17; SB7SP-16) The visible portion of the cutblock and entire landscape are outside of current Visual Landscape Inventory. Nearest VSU to south (4k) is Modification. Photo evidence from Tyson Leudtke indicates partial screening. No further analysis deemed necessary by RDI.

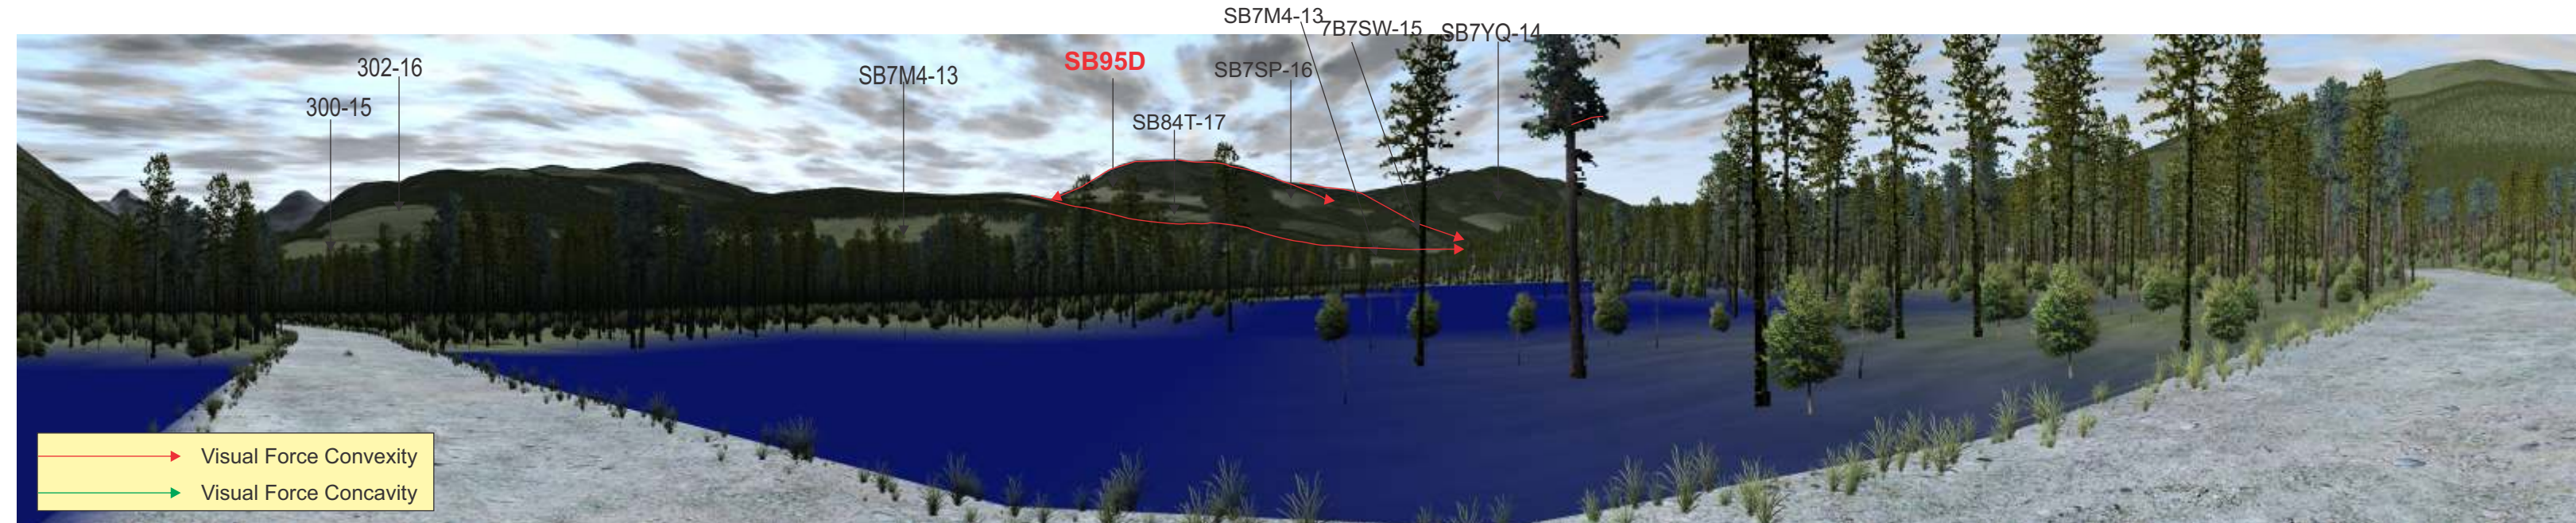
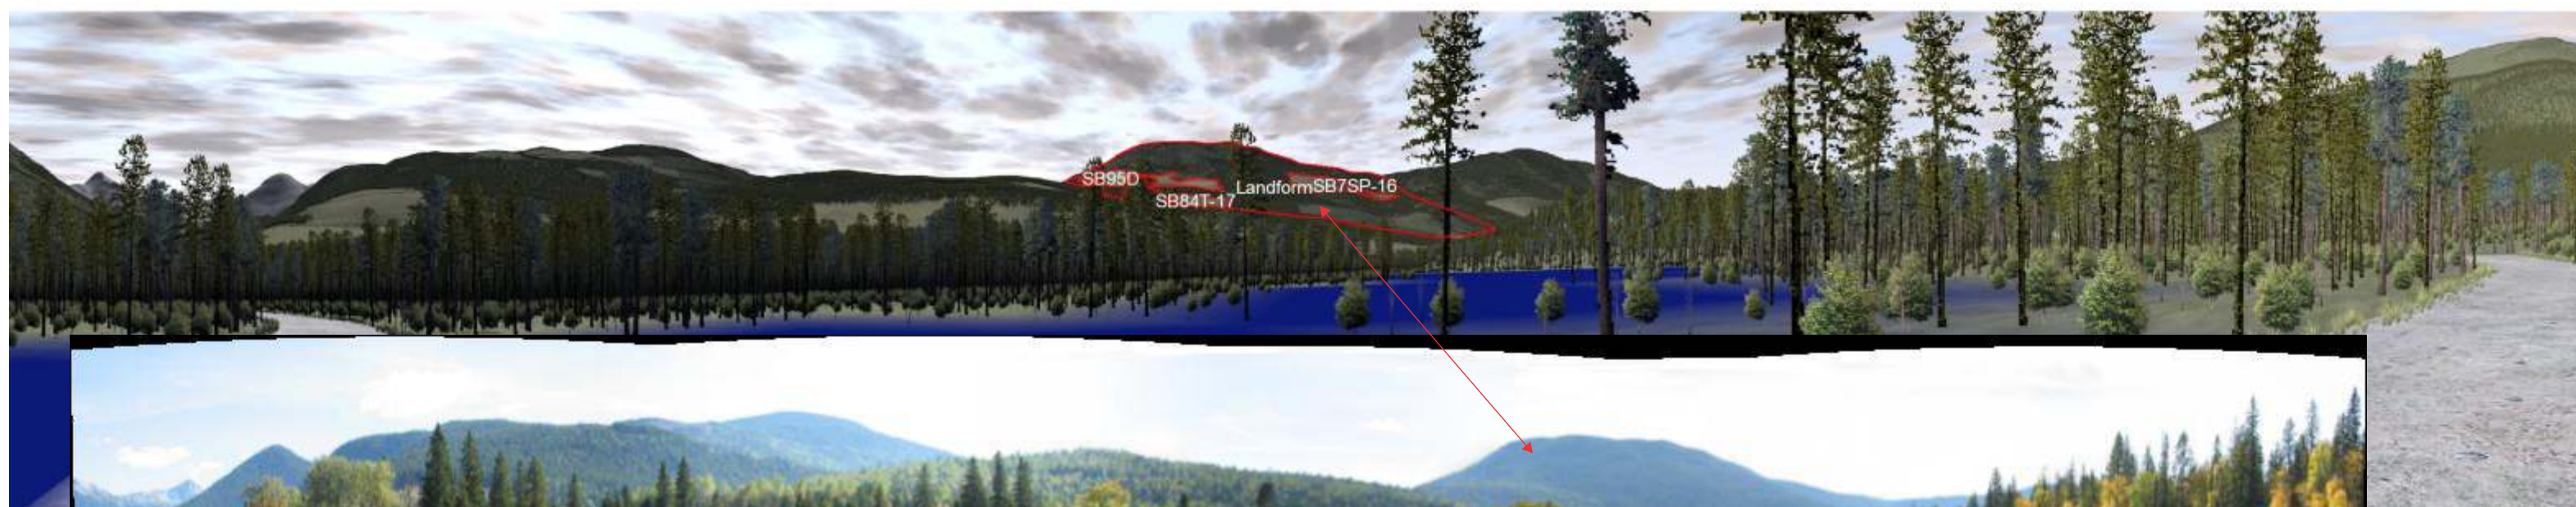
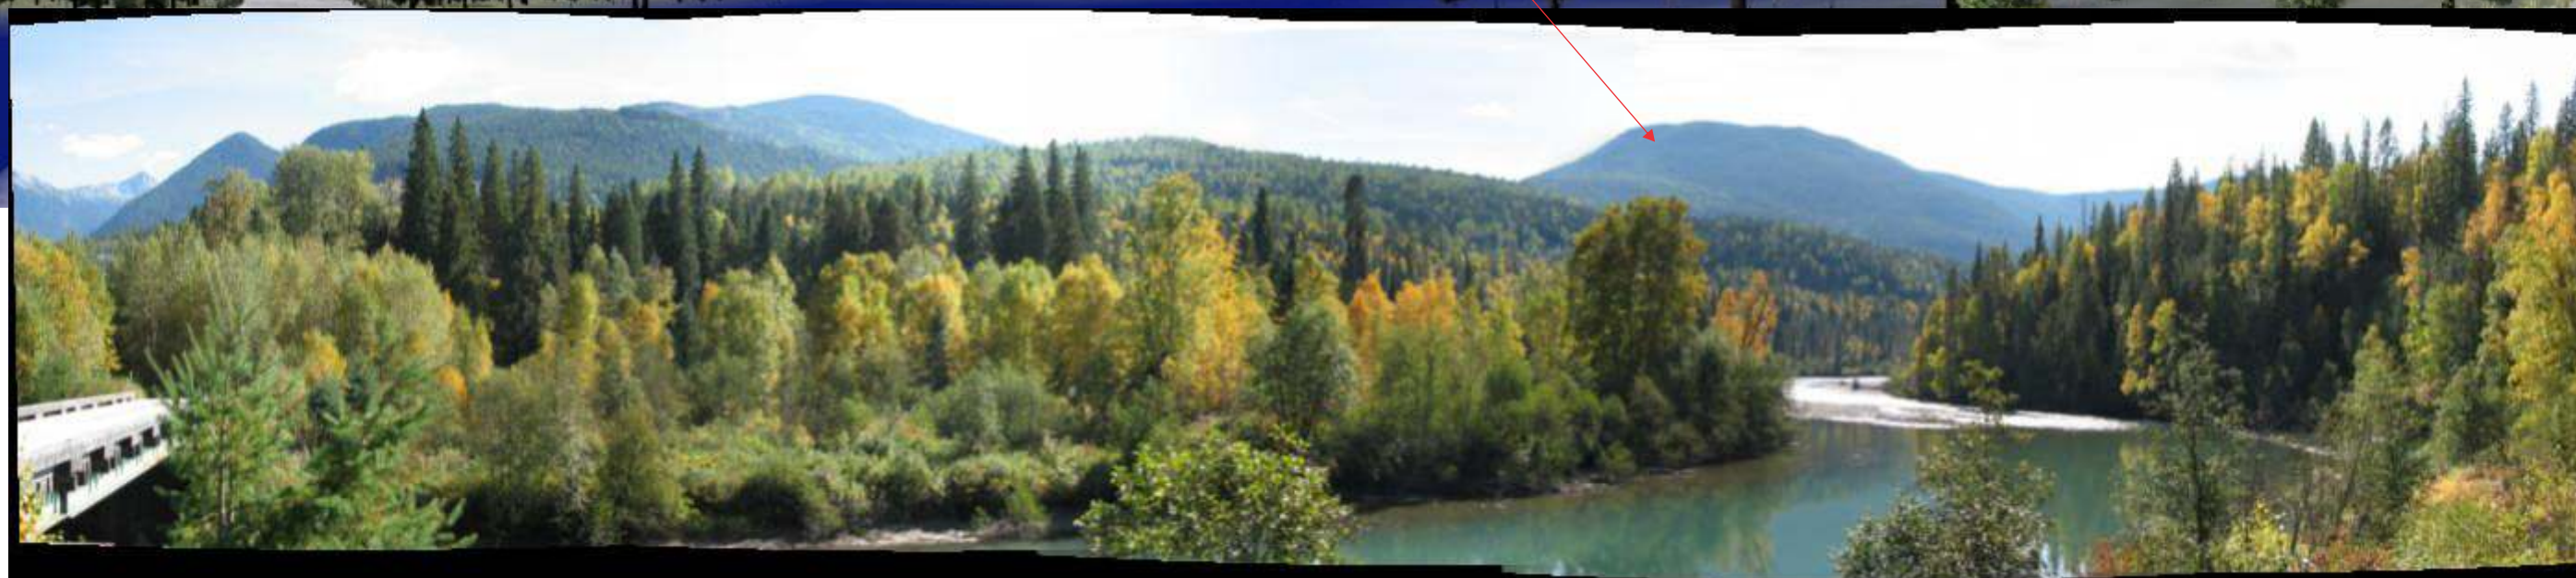
Viewpoint 3.3 - Bridge - no VP clearing- no on-site viewpoint determination

Percent Alteration Viewpoint 3.3 (Bridge)		
Features	AREA2	% Alt.
Landform	67062.73	
SB95D	3956.59	5.90%
SB84T-17	1960.01	2.92%
SB7SP-16	3490.52	5.20%
Sum Alt.	9407.12	14.03%

SB95D is a well-shaped compatible element in the landform as identified in red by RDI. New and existing cutblocks follow visual force lines. Viewing distance 3.2k. Presence of recent alteration in the same landform (SB84T-17; SB7SP-16) The visible portion of the cutblock and entire landscape are outside of current Visual Landscape Inventory. The Percent Alteration will Achieve Modification Category of Altered Forest. Modification is the VQO of the closest VSUs 4k to the south along the river. Open view confirmed by Leudtke photos. No further analysis or adjustments deemed necessary by RDI.

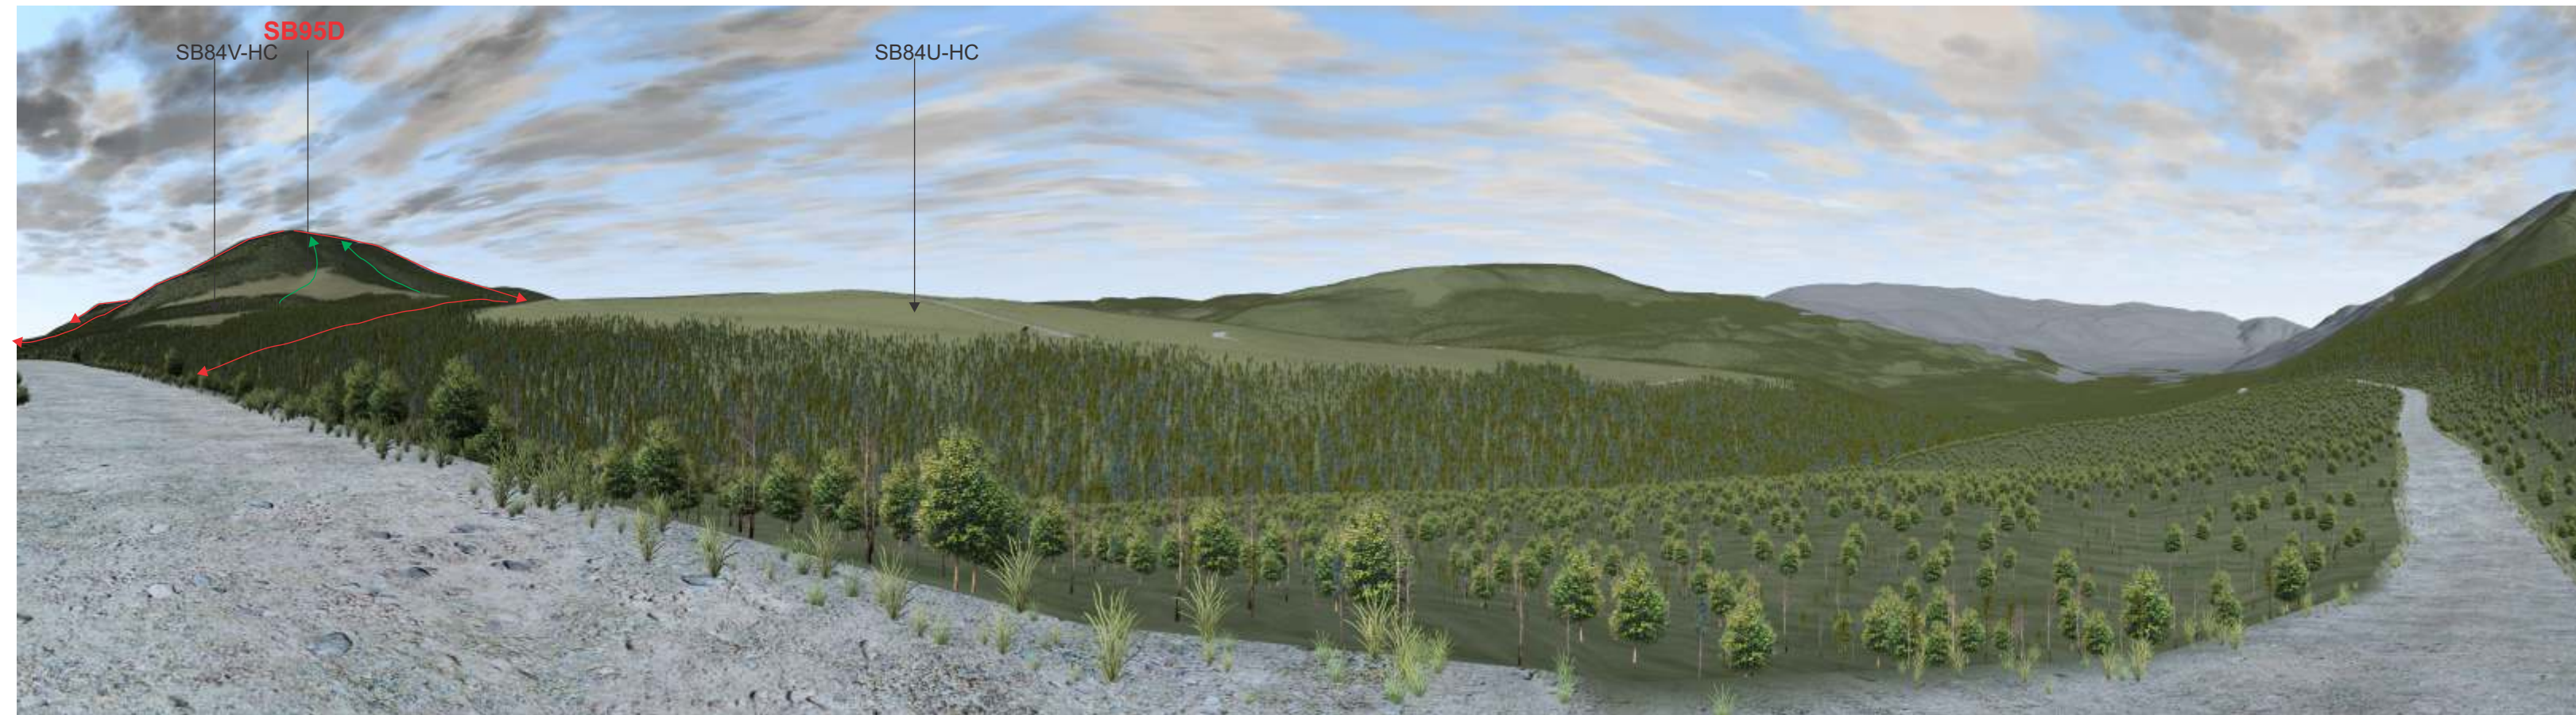
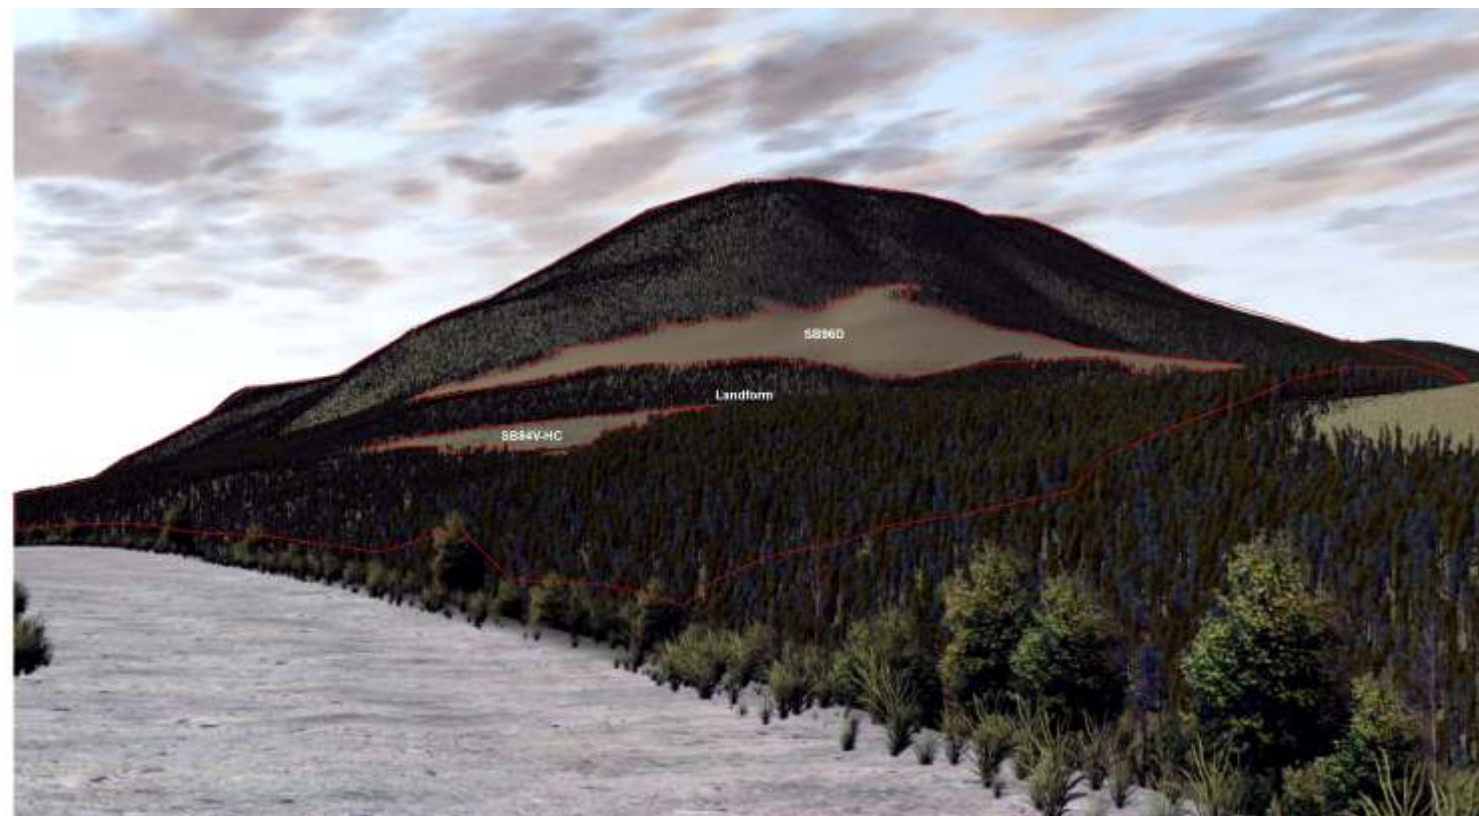
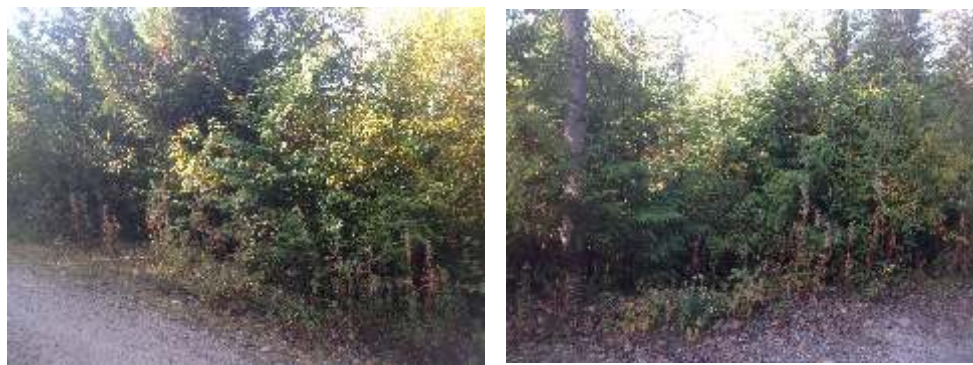
Viewpoint 3.4 - no viewpoint clearing- no on-site viewpoint determination

SB95D is a well-shaped compatible element in the landform as identified in red by RDI. New and existing cutblocks follow visual force lines. Viewing distance 1050m. Presence of recent alteration in the same landform (SB84V) also compatible in the landform. The visible portion of the cutblock and entire landscape are partly within VSU 258 (VLI_Poly 996). The VQO for that VSU is Partial Retention. VQO achieved is Modification by Percent Alteration. The viewpoint represents transient travel along the low-use road. The landform is a minor component in the view, and is dominated by the foreground alteration (SB84U-HC) in a separate landform. Fully screened view confirmed by Leudtke photos. No further analysis or adjustments deemed necessary by RDI.

Percent Alteration Harbour Viewpoint 3.4		
Features	AREA2	% Alt.
Landform	142073.73	
SB96D	12992.97	9.15%
SB84V-HC	2530.92	1.78%
Sum Alt.	15523.89	10.93%

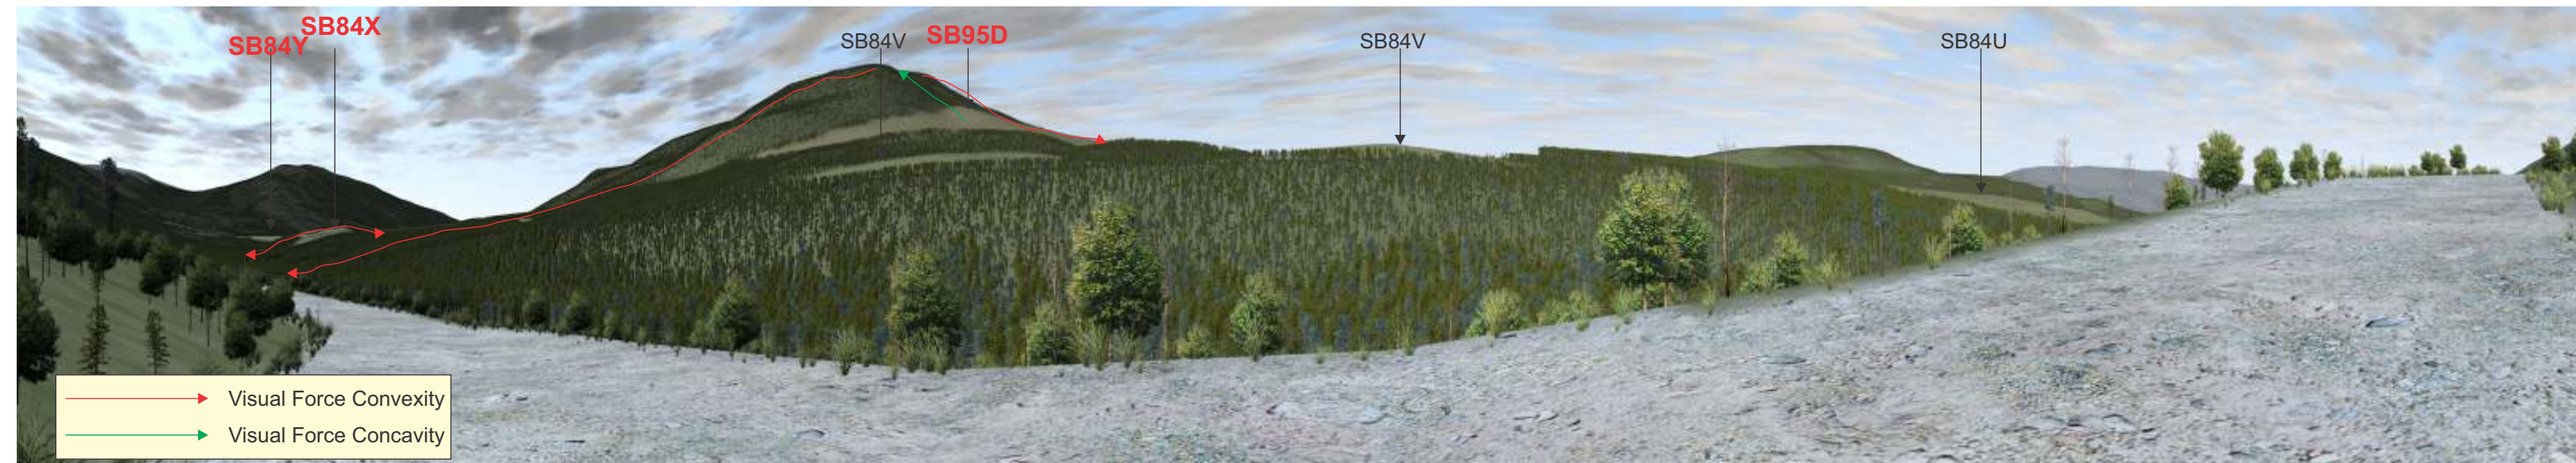
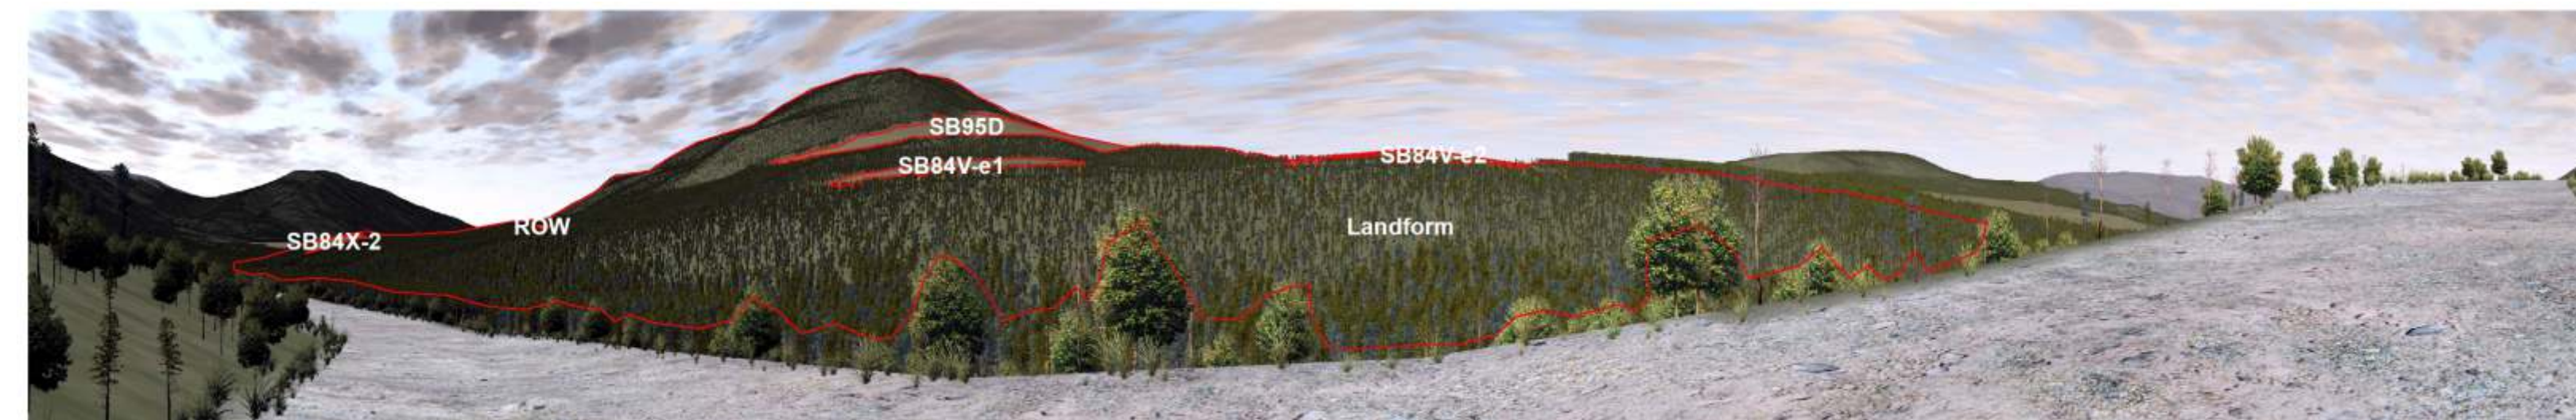
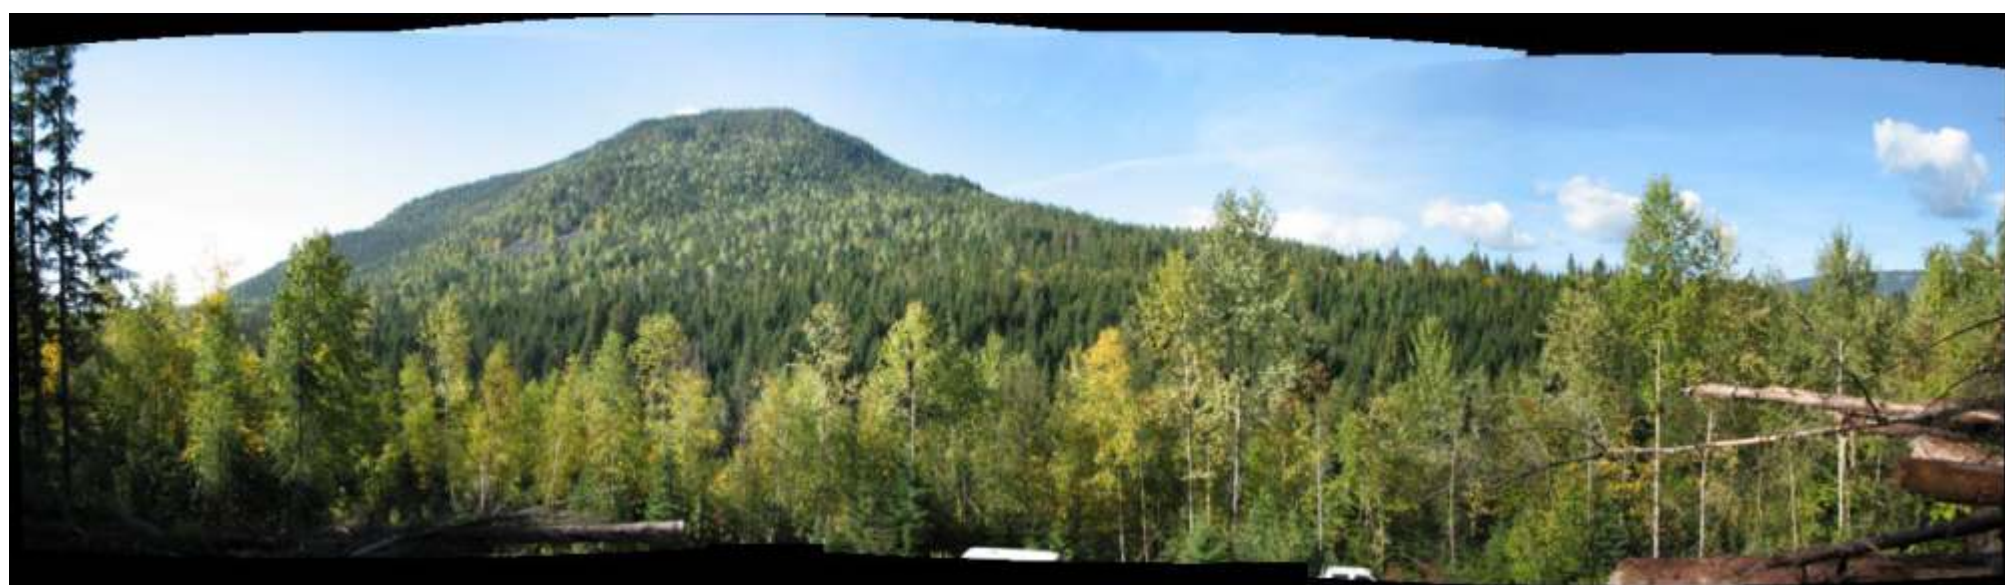
Viewpoint 3.5- no viewpoint clearing- on-site photography confirmed open viewing

Percent Alteration Harbour Viewpoint 3.5		
Features	AREA2	% Alt.
Landform	856533.31	
ROW	120.96	0.01%
SB84X-2	1298.77	0.15%
SB95D	13886.45	1.62%
SB84V-e2	3849.46	0.45%
SB84V-e1	6570.93	0.77%
Sum Alt.	25726.59	3.00%

SB95D has good shape following lines of force and repeats the form of SB84V (existing). The majority of SB84V is mainly obscured on the ridgeline. SB84X-2 occupies a small hillside within the main landform (25m elev.) and is NVS according to photos. RDI considers this hill to be too small to isolate it from the main landform. The VSU also incorporates the hill. (See also Dudgeon Lake, Road 1, and 3.6 Viewpoints). SB84Y (existing) is seen near SB84X outside of the main landform, and forms an acceptable pattern. It is NVS in the photo. SB84U is outside the main landform on the right, also screened in the photo. Together, proposed and existing alterations of 3% Percent Alteration and are well within the Partial Retention Category of Altered Forest (1.5% to 7.0%).
