**North-East Harbour
Final Visual Assessment
October 21, 2017
RDI Resource Design Inc**

Discussion and Conclusions

A visual impact assessment was conducted by RDI for the proposed cutblocks SB95D and SB84X plus a complexity of related existing cutblocks. The analysis cutblocks lay within VSU996 which has an established VQO of Partial Retention, and are located in mapsheet 082m065. Having no opportunity for on-site orientation, RDI sought and tested best viewing opportunities along the roads and on Dudgeon Lake using Visual Nature Studio. The trial approaches consumed considerable rendering effort. In all, 8 viewpoints were selected for analysis. The major portion of SB95D is outside of the VSU on the north-west facing part of the landform. The viewpoints on the west side of Adams River up to and including the bridge crossing (Viewpoint 3.3) see only this unclassified landform. The nearest VSU to the south seen from the west side of the river is VSU 1013 which has an established VQO of Modification. That VSU contains proposed cutblocks SB95C and SB95E which are assessed in a separate report by RDI.

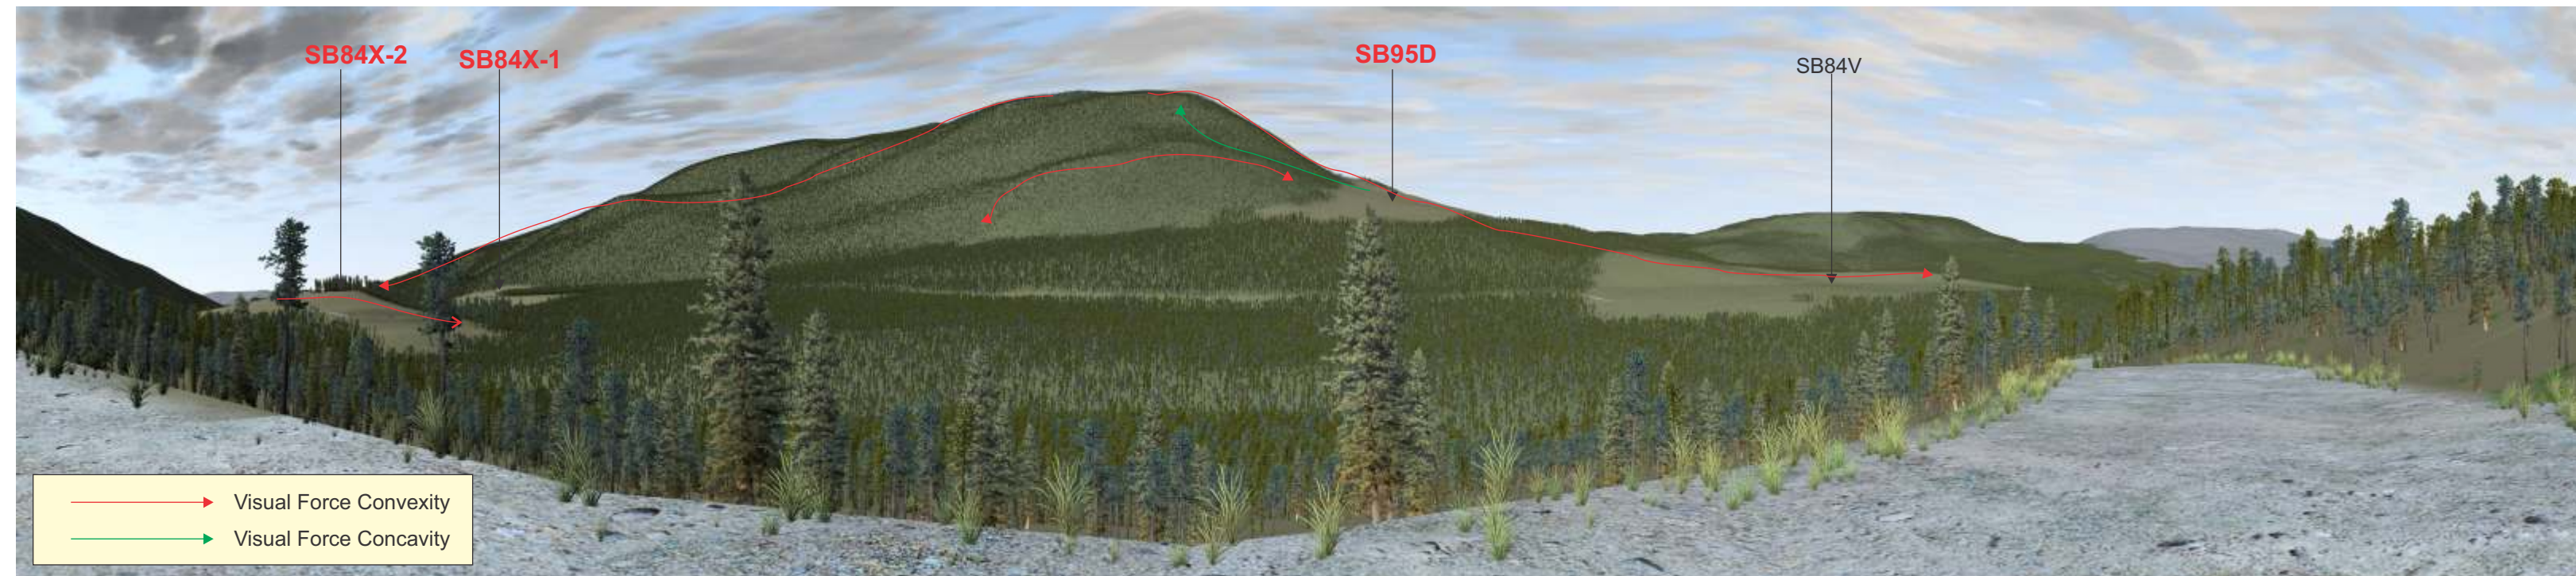
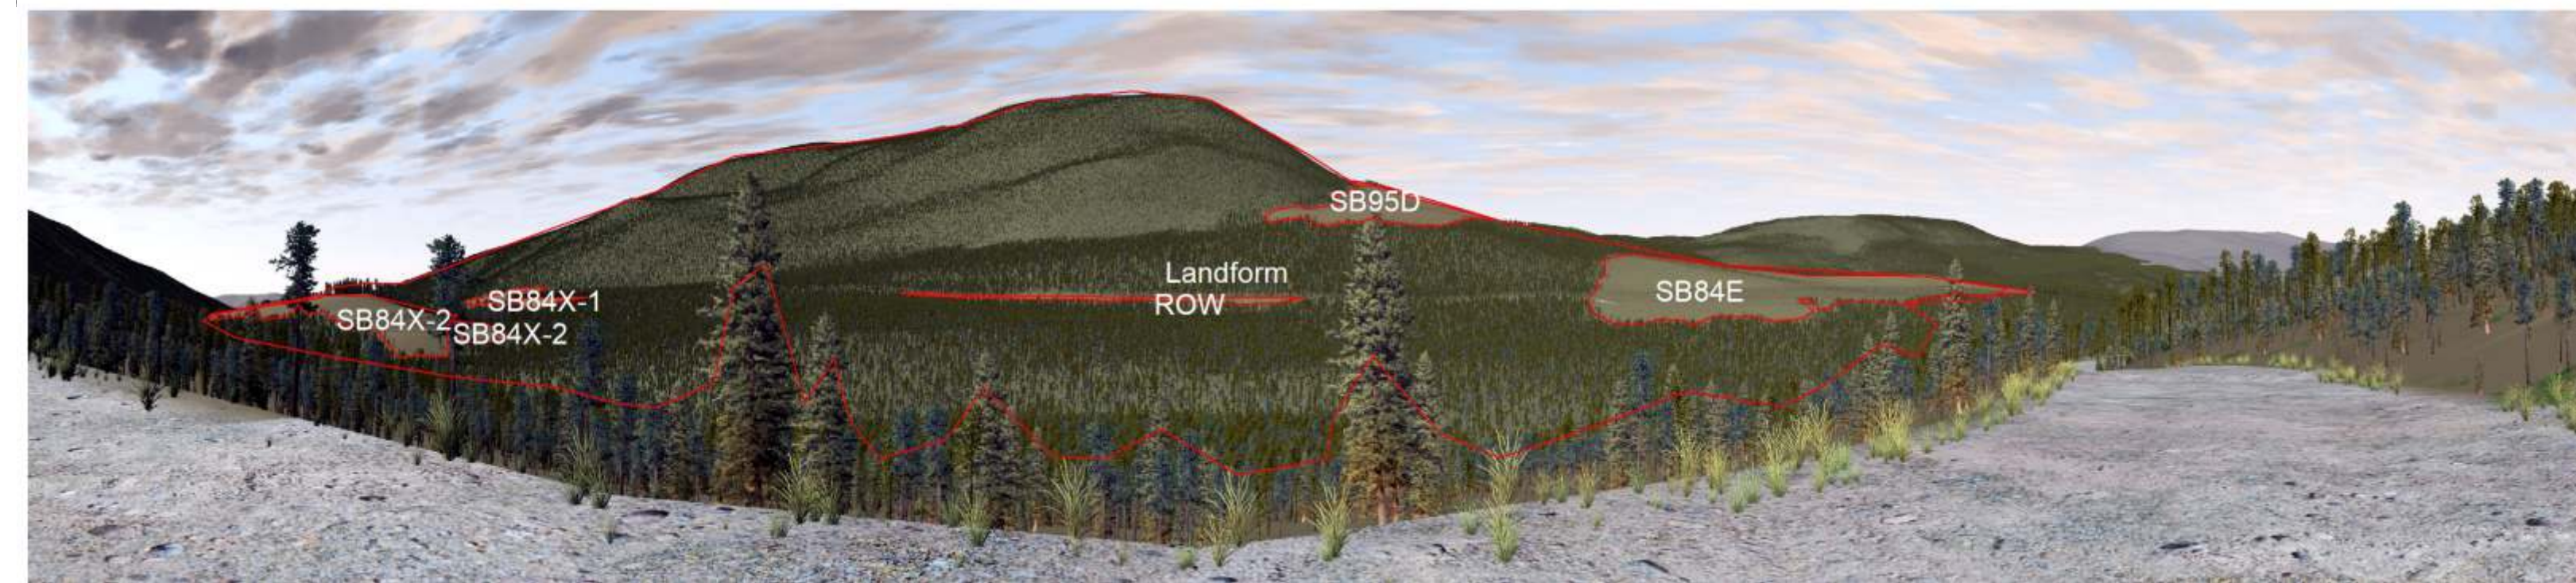
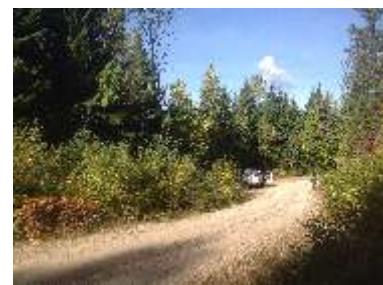
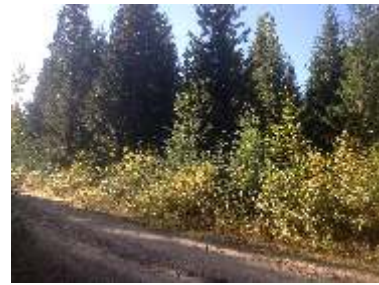
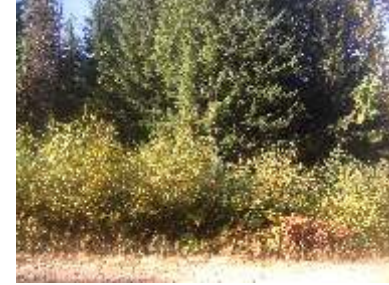
Percent Alteration Viewpoint 3.6		
Features	AREA2	% Alt.
Landform	1335849.12	
SB84X-2	26421.25	1.98%
SB84X-1	3288.04	0.25%
SB95D	17823.46	1.33%
SB84V-E	63121.36	4.73%
ROW	5491.01	0.41%
Sum Alt.	116145.12	8.69%

SB95D has good shape following lines of force. SB84X-1 is low and is shaped well and compatible with the landform. SB84X-2 occupies a small hillside within the main landform (25m elev.). RDI considers this hill to be too small to isolate it from the main landform. The VSU also incorporates the hill. (See also Dudgeon Lake and Road 1 Viewpoints). Existing cutblock SB84V is prominent on the right side of the landform and acceptable shape. Together, proposed and existing alterations exceed the Partial Retention (1.5% to 7.0%). Overall pattern closely meets PR. Leudtke photos indicate full screening. RDI makes no design suggestions for this transient low-traffic view. See also Dudgeon Lake and Road 1 viewpoints.

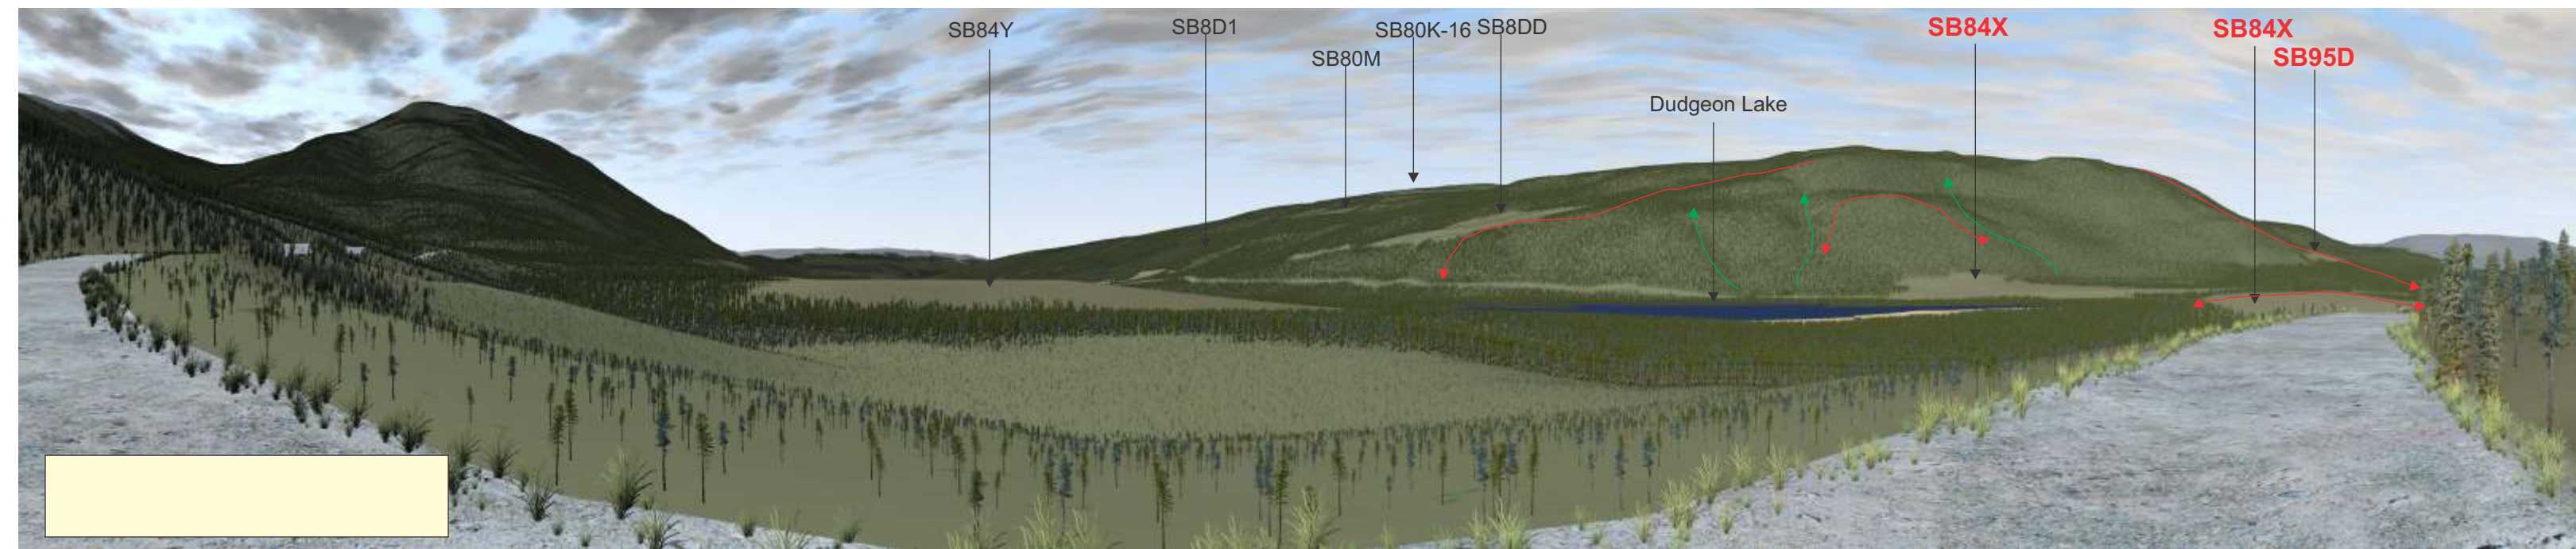
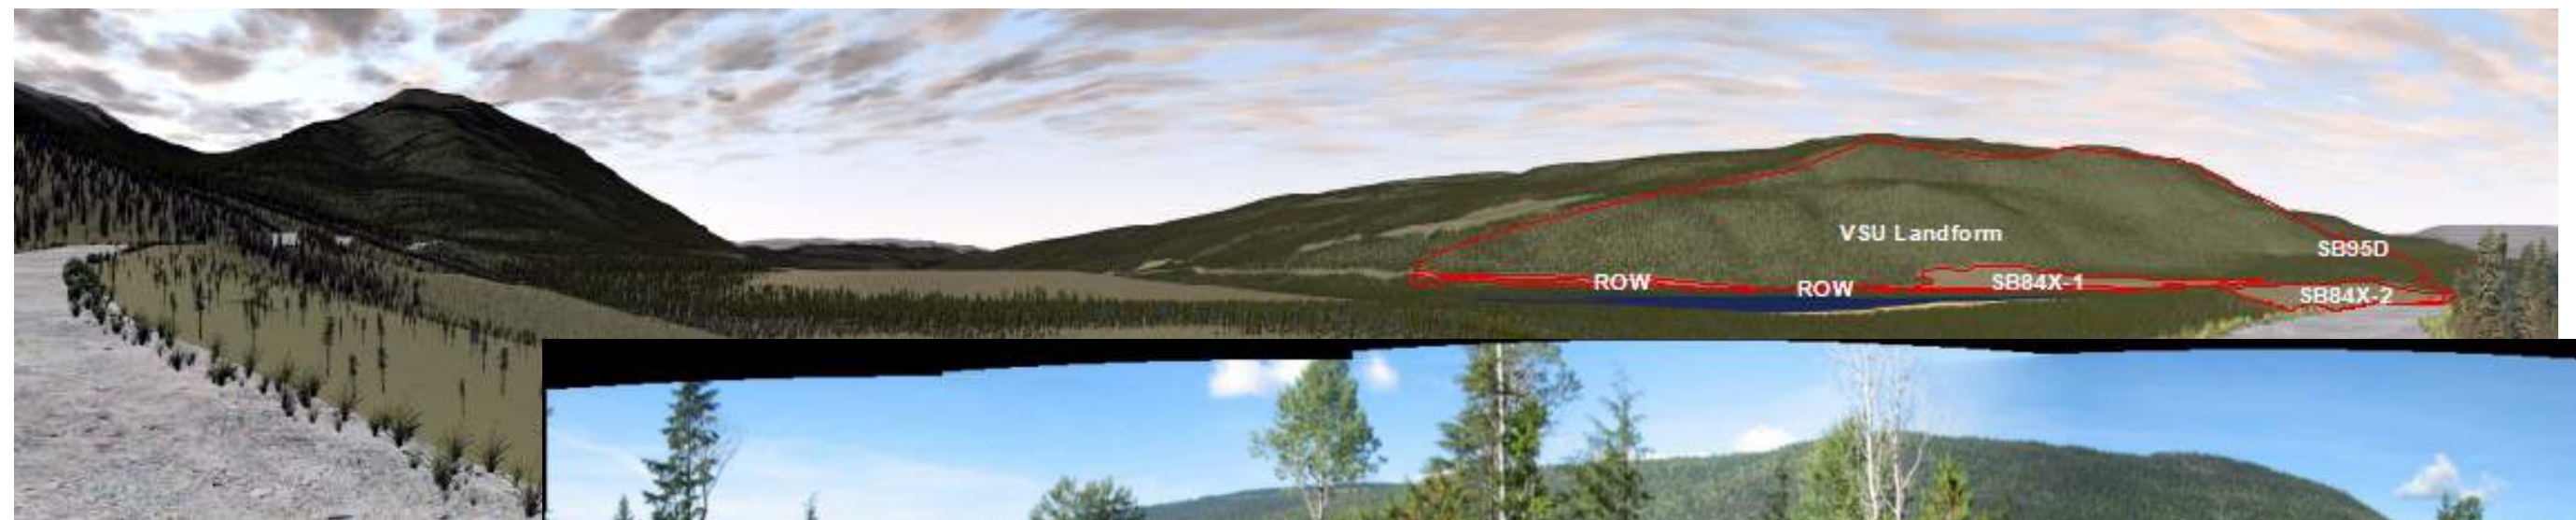
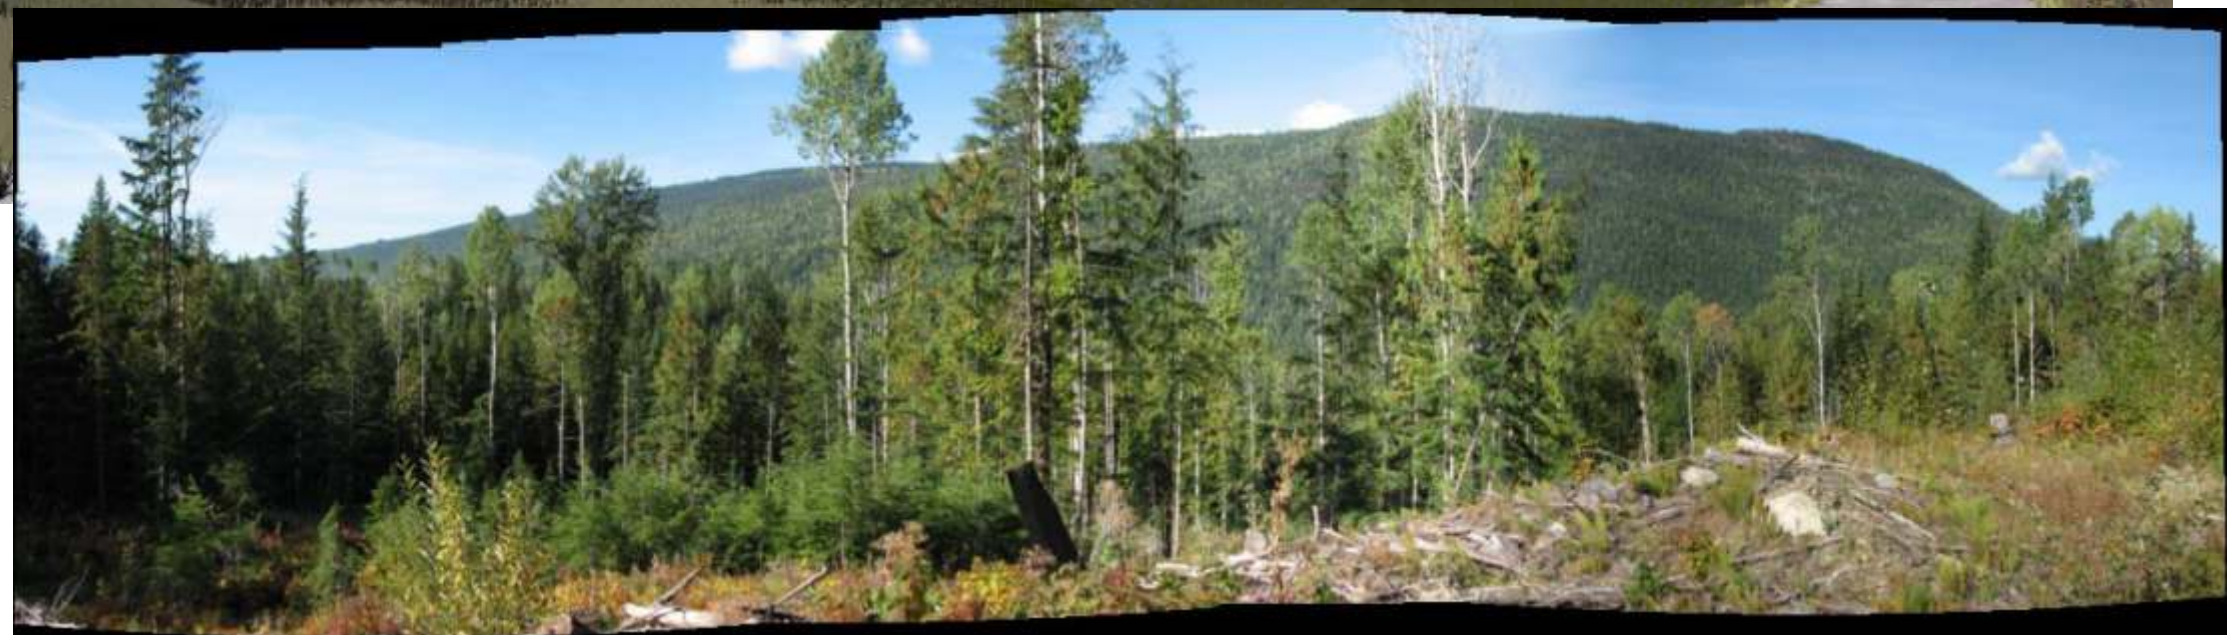
Viewpoint Road 1 - with no VP clearing

Percent Alteration Road1 Viewpoint		
Features	AREA2	% Alt.
VSU Landform	373086.51	
SB95D	923.33	0.25%
SB84X-2	14273.91	3.83%
SB84X-1	16229.11	4.35%
ROW	4975.30	1.33%
Sum Alt.	36401.65	9.76%

SB95D is a minor element in the landform with good shape following lines of force. SB84X-1 is low and is shaped well and compatible with the landform. SB84X-2 occupies a small hillside within the main landform (25m elev.). RDI considers this hill to be too small to isolate from the main landform. The VSU also incorporates the hill. (See also Dudgeon Lake and 3.6 Viewpoints). The road ROW follows the shoreline visual force above the park boundary - no roads are evident. Total Percent Alteration of 9.76% exceeds the Partial Retention Category of Altered Forest (1.5% to 7.0%) if not screened. Design options such as elimination or modification of SB84X-2 would bring the total alteration within limits from this viewpoint. However, the viewpoint is low-use transient viewing therefor RDI makes no recommendation to change. There is recent alteration in the foreground along the east-side of the lake. Most importantly, the Leutke photos indicate little or no visibility of recent or proposed alterations.

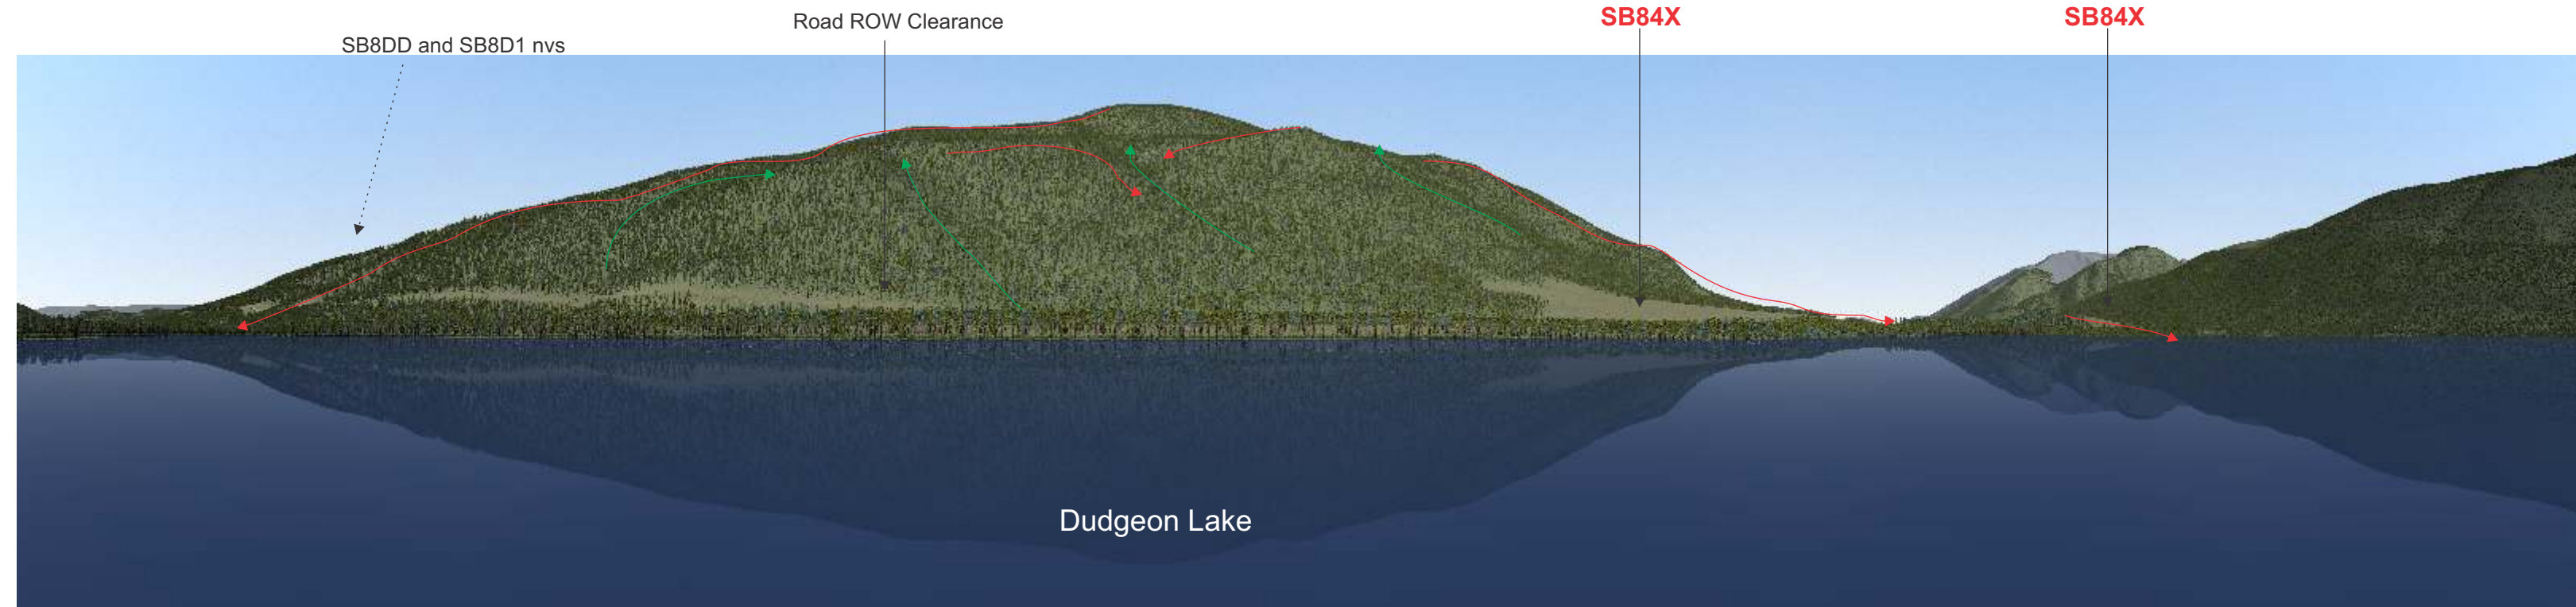
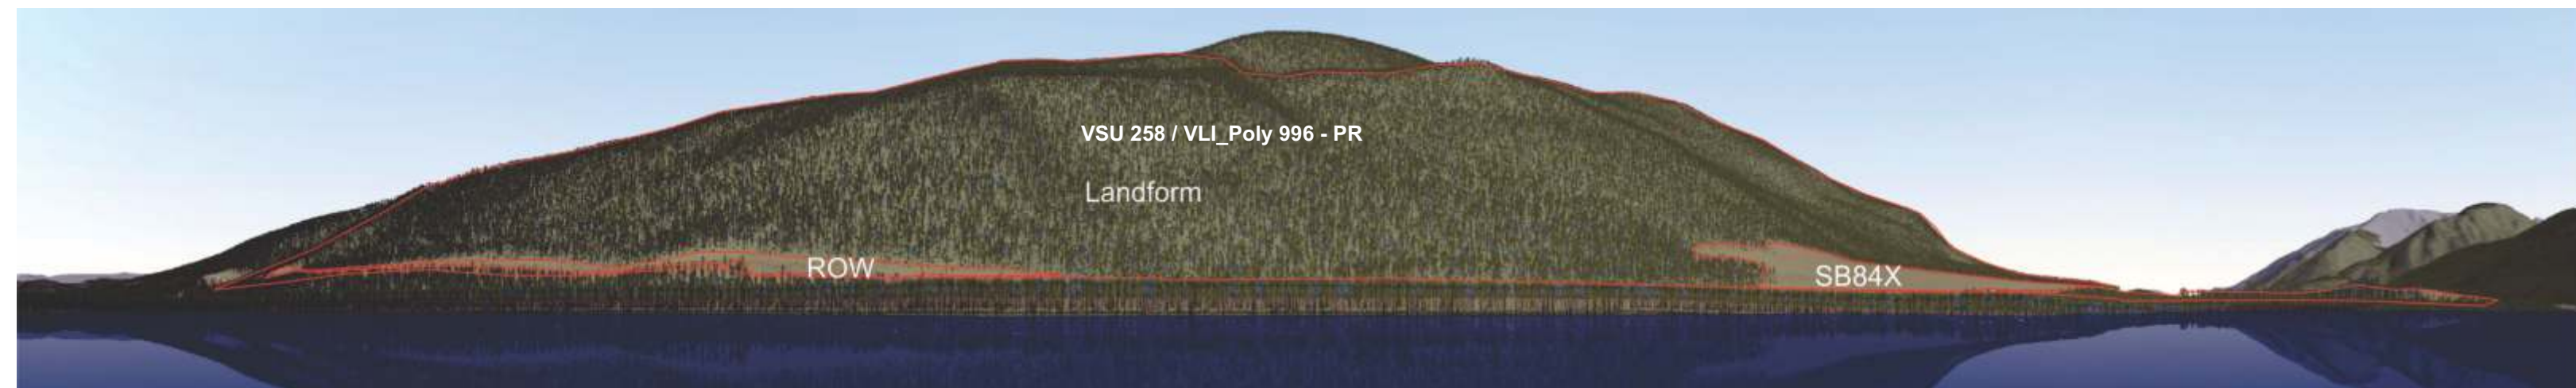
Dudgeon Lake Viewpoint - West View

Percent Alteration Dudgeon Lake VP		
Features	AREA2	
Landform	740532.10	
SB84X	21647.97	2.92%
ROW	17738.97	2.40%
Sum Alt.	39386.93	5.32%

The view from Dudgeon Lake is from within the Provincial Park boundary, providing emphasis to meet the VQO from this viewpoint. SB84X is low and to one side, and is shaped well and compatible with the landform. The block extends to a small hill on the far right side of the landform. The hill is viewed contiguously from this viewpoint and is not considered to be large enough to differentiate it as a separate landform. (See also Road 1 and 3.6 Viewpoints). The road ROW follows the shoreline visual force above the park boundary - no roads are evident. Percent Alteration meets Partial Retention Category of Altered forest. There is recent alteration along the east-side of the lake (see next page).

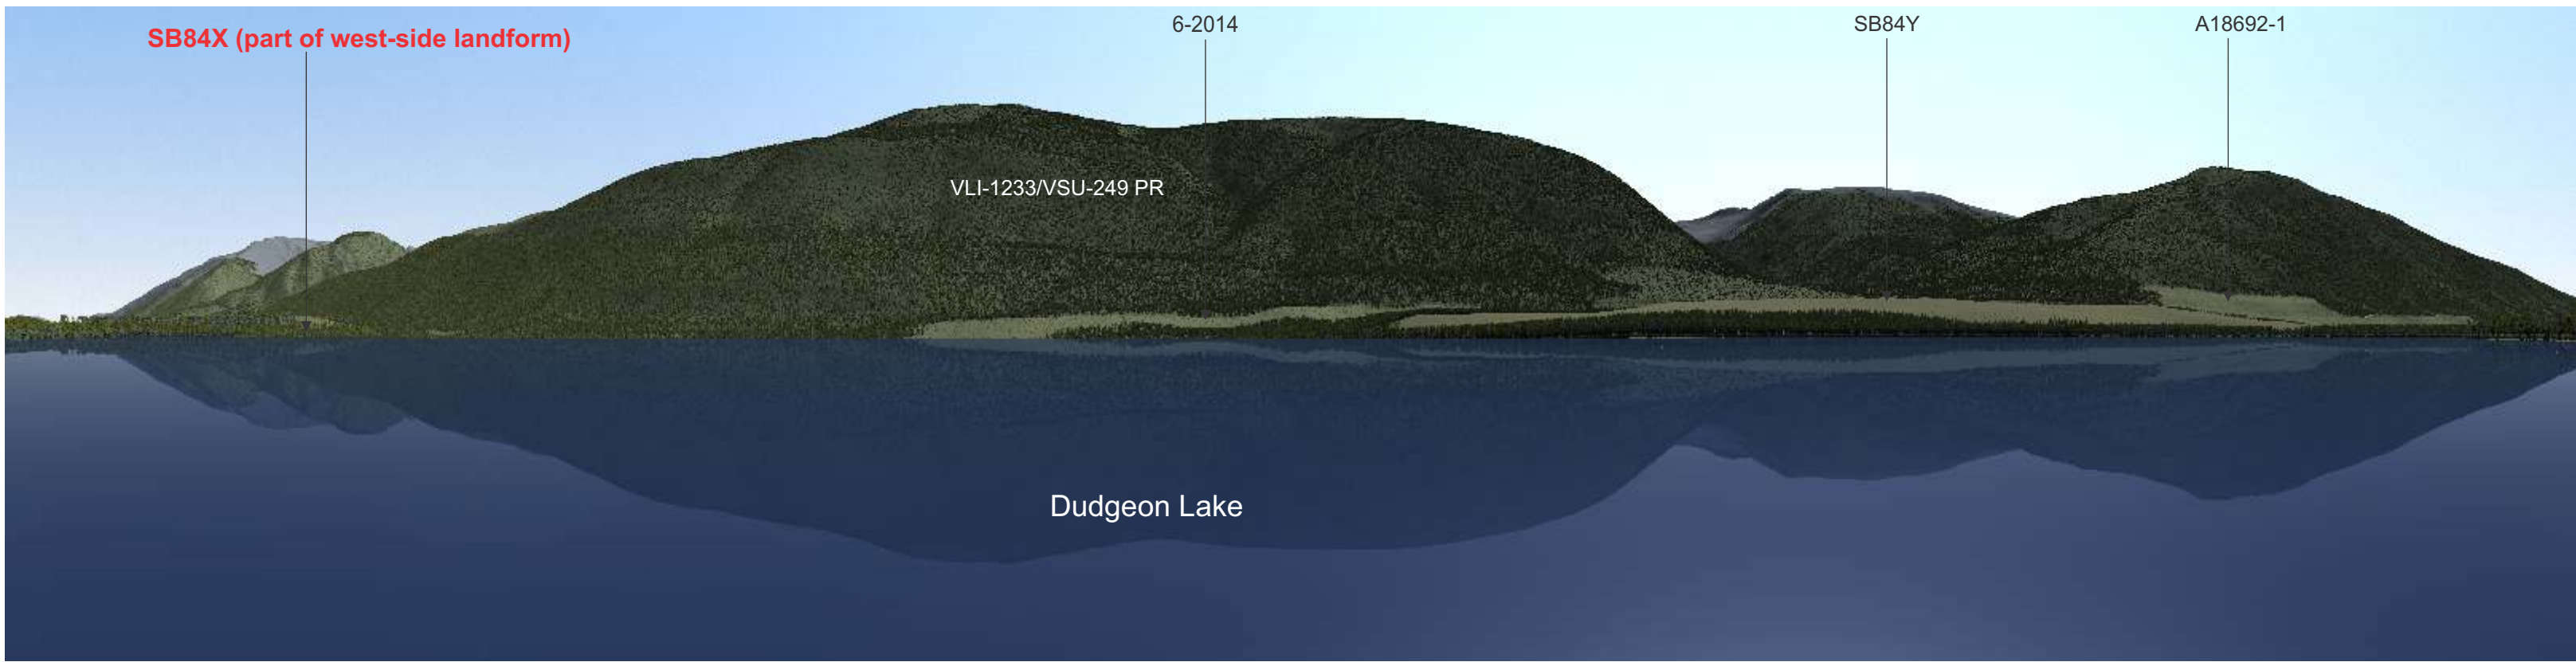
East-side Landform

Cutblocks are low along the landforms. No new cutblocks. No roads are evident.
No previous proposal assessments requested of RDI - No further analysis by RDI.
There is recent and proposed alteration along the west-side of the lake (see previous page).
